Effect of Surface Working Operations on Electrochemical Corrosion and Susceptibility to Stress Corrosion Cracking of 304L Stainless Steel

A thesis submitted to the

Doctor of Philosophy

Homi Bhabha National Institute

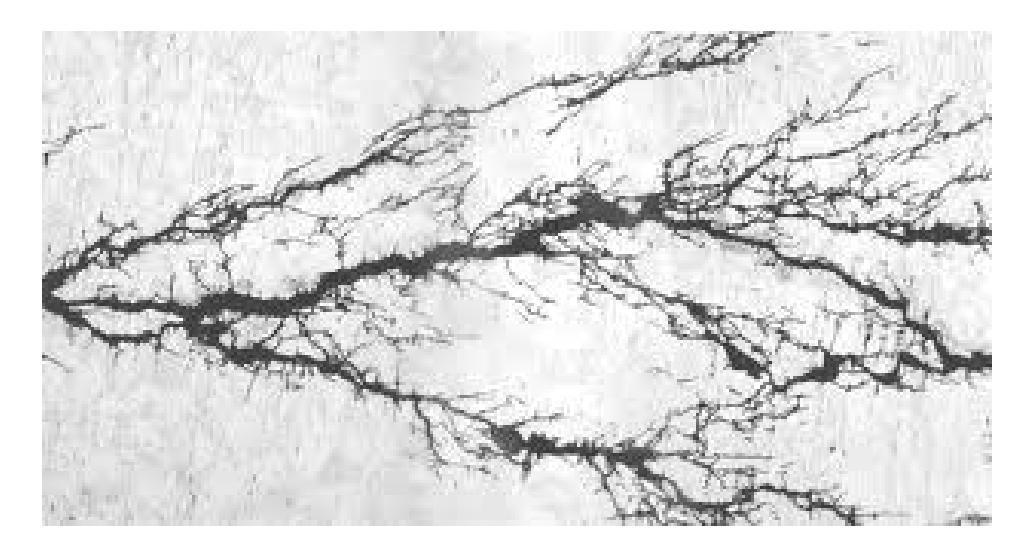
Fig. 2.1 Chloride induced TGSCC in stainless steel showing crack branching [12].

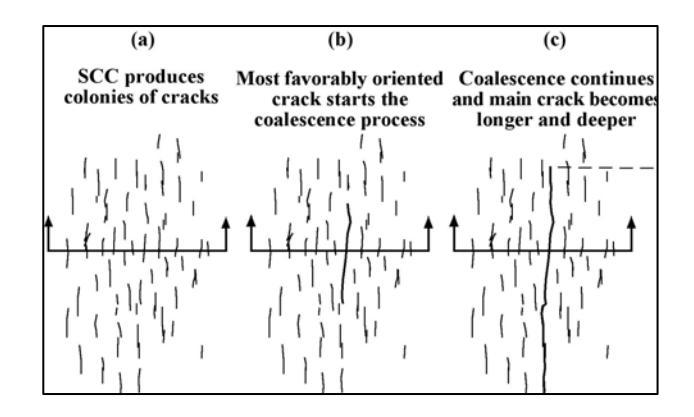
Fig. 2.2 Schematic showing different stages involved in stress corrosion cracking [3]. Arrows indicate direction of crack growth.

propagation increases, and the crack opening increases. Many different mechanisms have been proposed to explain the synergistic stress-corrosion interaction that occurs at the crack tip, and there may be more than one process that causes SCC. The proposed mechanisms can be classed into two basic categories: a) anodic mechanisms and b) cathodic mechanisms. During corrosion, both anodic and cathodic reactions must occur, and the phenomena that result in crack propagation may be associated with either class of reactions. The most obvious anodic mechanism is that of simple active dissolution and removal of material from the crack tip. The most obvious cathodic mechanism is hydrogen evolution, absorption, diffusion, and embrittlement. Crack propagation mechanisms assume that breaking of the interatomic bonds of the crack tip occurs by one of the following mechanisms: a) chemical solvation and dissolution, b) mechanical fracture (ductile or brittle). Mechanical fracture includes normal fracture processes that are assumed to be stimulated or induced by one of the following interactions between the material and the environment: adsorption of environmental species, surface reactions, reactions in the metal ahead of the crack tip, surface films formation, surface film rupture. All of the proposed mechanisms contain one or more of these processes as an essential step in the SCC process. Specific mechanisms differ in the processes assumed to be responsible for crack propagation and the way that environmental reactions combine to result in the actual fracture process. Typically SCC takes place by crack nucleation at multiple locations followed by crack growth. The most favourably oriented cracks then coalesce to finally form a deep crack (Fig. 2.2: arrows indicate direction of crack propagation).

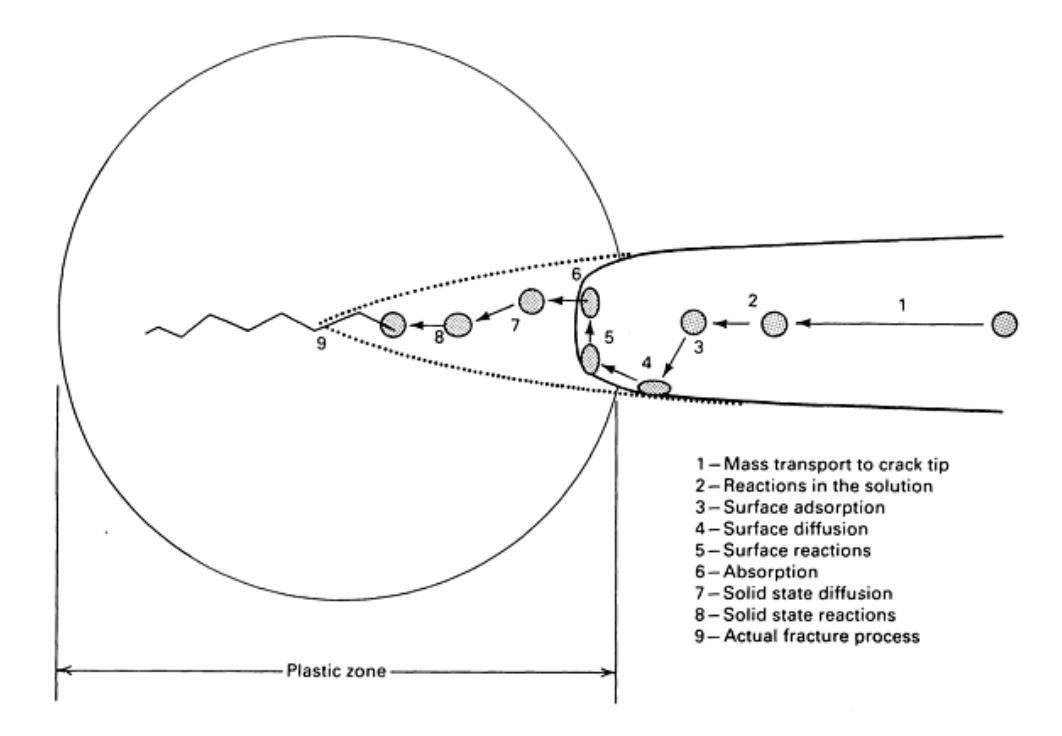
Fig. 2.3 Schematic of crack tip processes that may be the rate-determining step in environmentally assisted crack propagation [36].

The mechanisms that have been proposed for SCC require that certain processes or events occur in sequence for sustained crack propagation to be possible. These are as follows: a) mass transport along the crack to the crack tip, b) reactions in the solution near the crack, c) surface adsorption at or near the crack tip, surface diffusion, d) surface reactions, e) absorption into the bulk, f) bulk diffusion to the plastic zone ahead of the advancing crack, g) chemical reactions in the bulk, h) rate of interatomic bond rupture. A schematic of crack tip processes that may be the rate-determining step in environmentally assisted crack propagation is shown in Fig. 2.3.

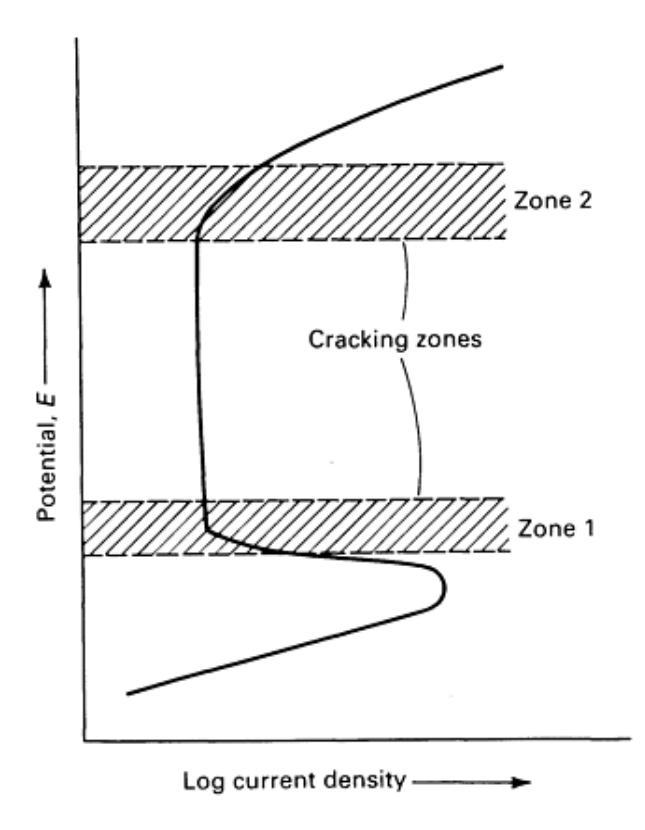
Fig. 2.4 Schematic of potentiokinetic polarization curve and electrode potential values at which stress-corrosion cracking occurs in stainless steels [36].

A thermodynamic requirement of simultaneous film formation and oxidation of the underlying material led to the identification of critical potentials for the presence or absence of SCC. An example of these critical potentials is shown in Fig. 2.4 for a passive film forming material such as stainless steel. Zones 1 and 2 in Fig. 2.4 are those in which transgranular stress corrosion crack growth is most likely to occur. Intergranular stress-corrosion crack growth can occur over a wider range of potentials than these two zones. Transgranular SCC occurs in zone 1 because the material is in transition from active corrosion to passive film formation such that the simultaneous conditions for film formation on the crack walls and corrosion at the crack tip are met. A similar condition exists in zone 2, with the added factor that these potentials are at or above the pitting potential so that cracks can initiate by pitting. Intergranular SCC occurs over a wider range of potentials than those shown for zones 1 and 2 because chemical inhomogeneities at the grain boundary produce a different electrochemical response relative to the bulk material. Therefore, passive crack walls and active crack tips can result over the potential range from zone 1 to zone 2.

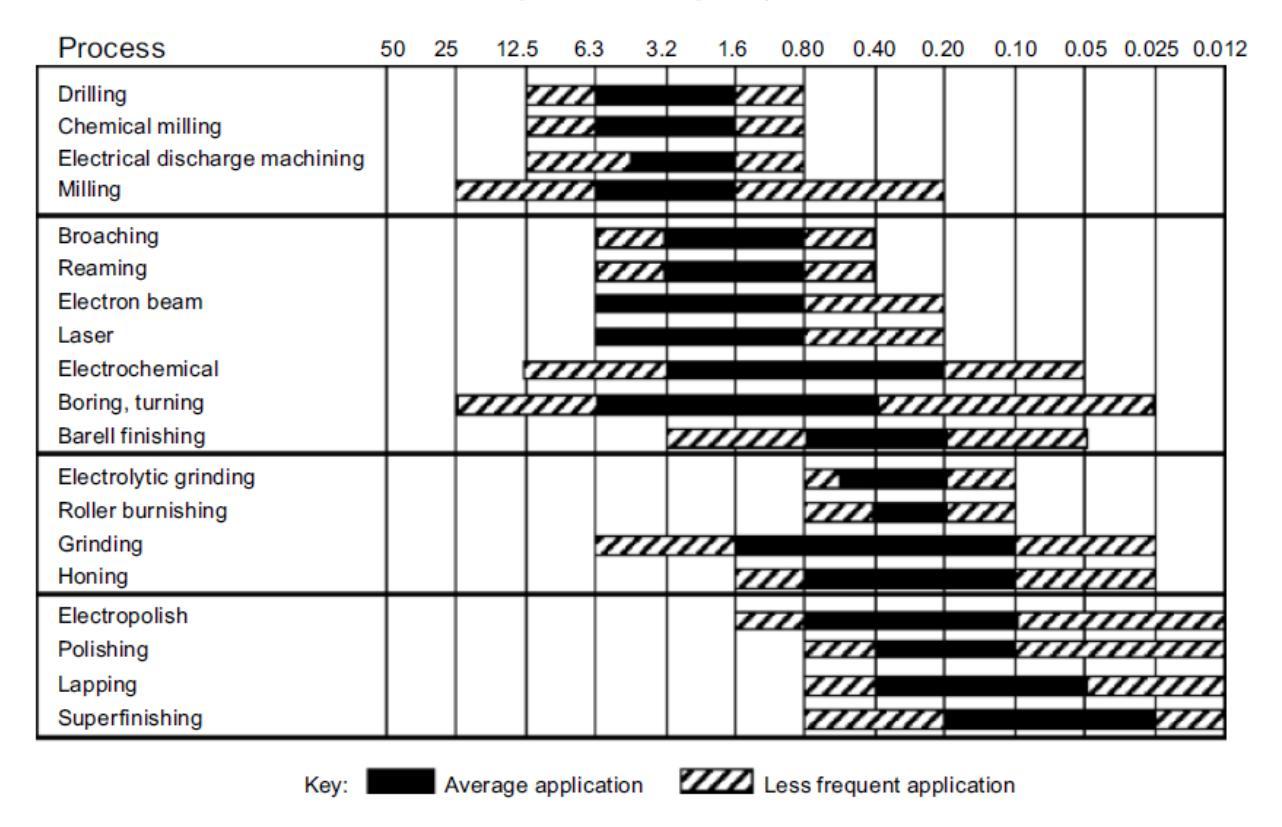
Fig. 2.6 Typical ranges of surface finish from common machining processes [56].

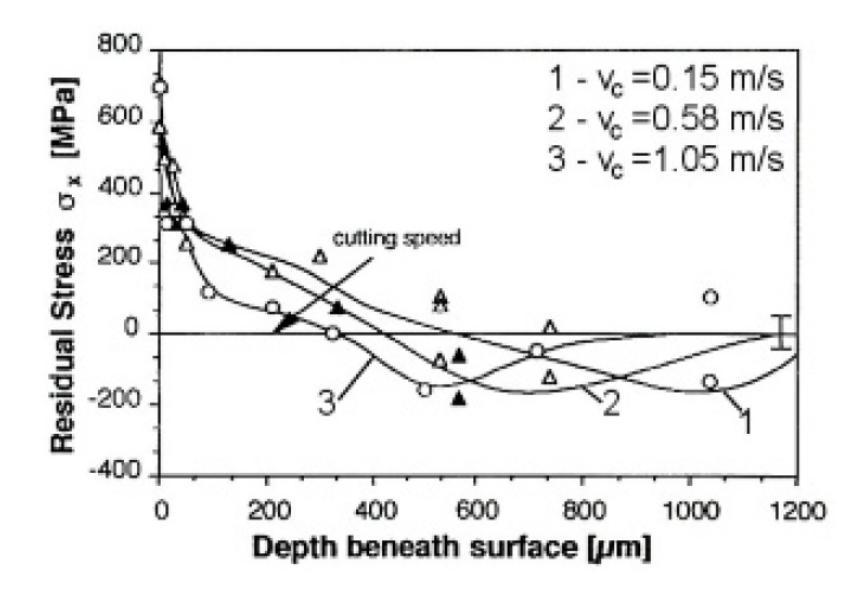
Fig. 2.7 Residual stress profile as a function of cutting speed for 304 stainless steel [56].

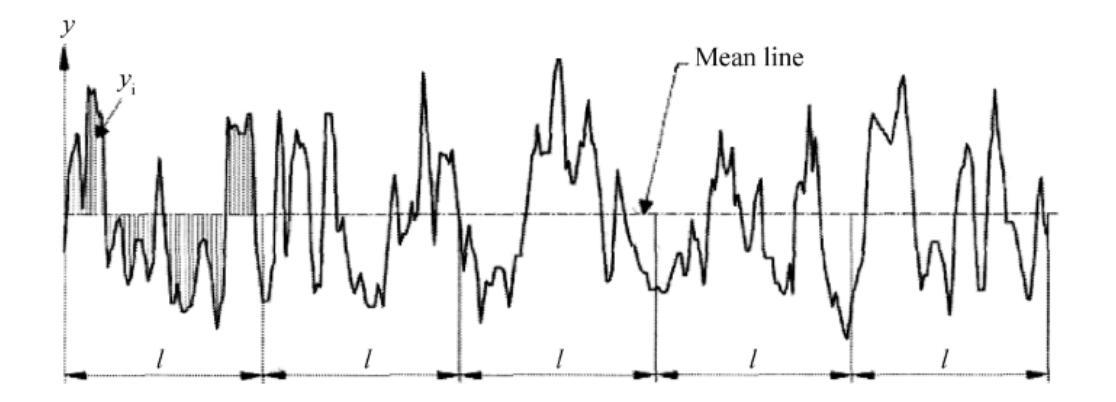
Fig. 3.1 Mean line system and definition of Ra [56]

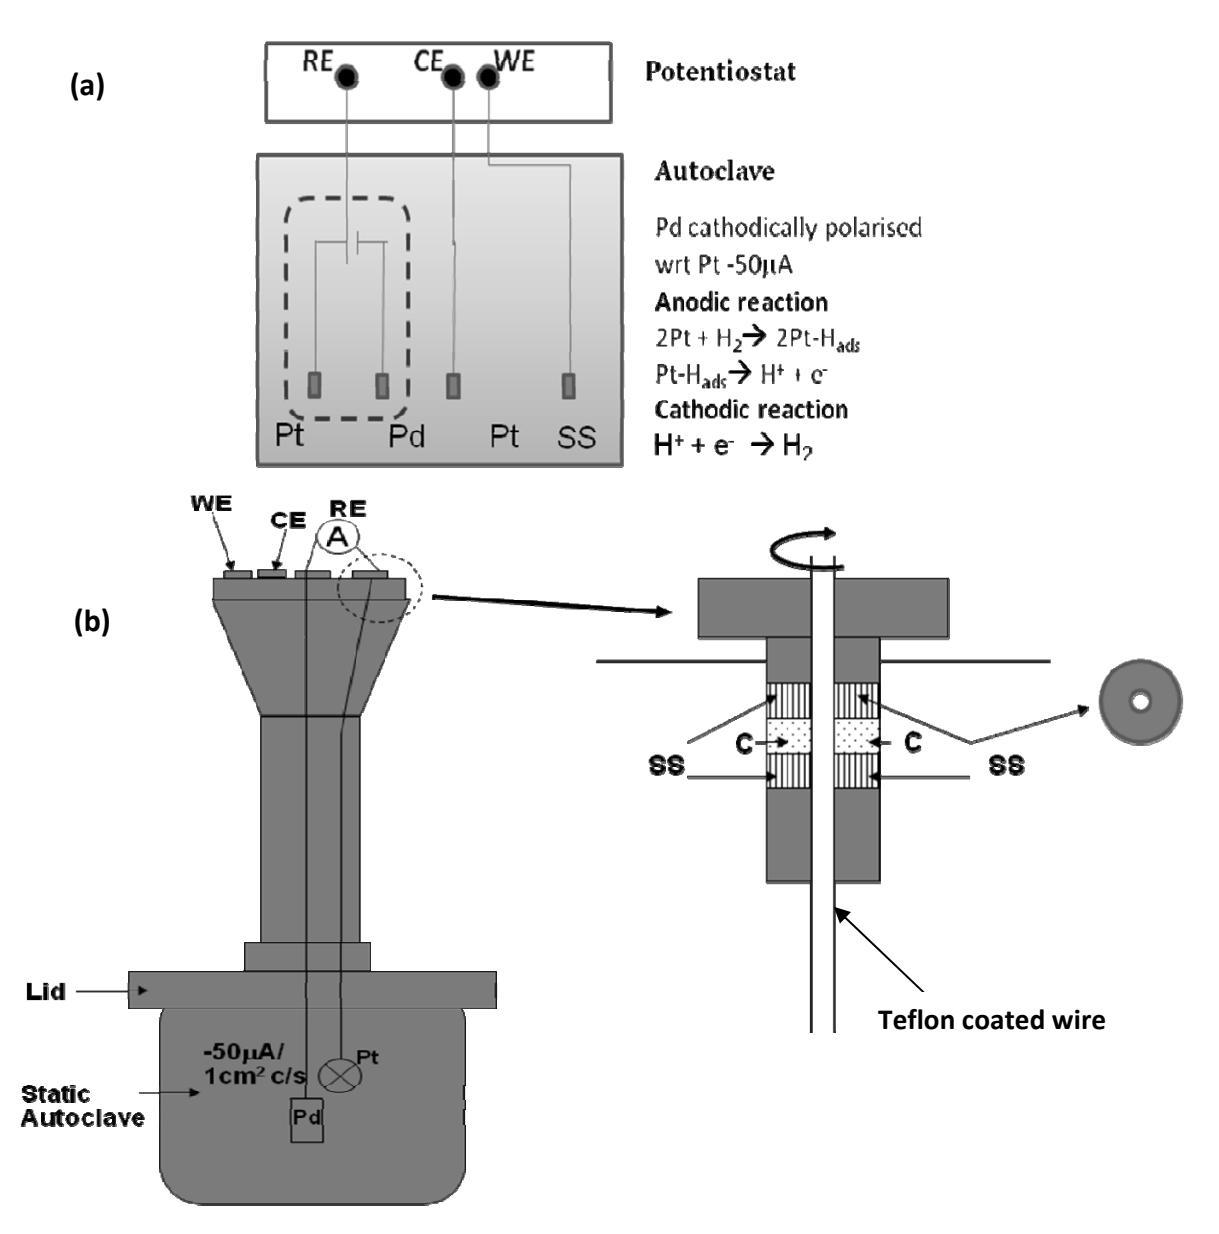
Fig. 3.2 (a) Schematic showing $Pd-H_2$ reference electrode set up inside an autoclave (b) design of the adapter and insulation for safe operation of the autoclave.

An existing static autoclave has been suitably modified for carrying out electrochemical measurements at HTHP conditions. An additional adapter for the flange of the autoclave has been indigenously designed and fabricated which has several ports for insertion of the Pd/H₂ electrode, sample and the counter electrode. Fig. 3.2 (a) shows the schematic of the three electrodes connected to a potentiostat. Cathodically polarized palladium reference electrode has been marked with dotted lines. Fig. 3.2 (b) shows the design of the adapter and insulation for safe operation of the autoclave. The wires used for connecting the electrodes to the potentiostat were coated with PTFE to provide electrical isolation from the body of the autoclave. The measurements at HTHP conditions require proper insulation of the autoclave for maintaining the required pressure and temperature. For this purpose O rings made of PTFE were used. In addition concentric rings made up of stainless steel (SS) with graphite wool packed in between (as shown in Fig. 3.2 b) were used. The PTFE coated wire was made to pass through these rings and finally through the bolt head. As the bolt at the top of the adapter is tightened, the SS rings compress the graphite wool in between. The graphite flows and it adheres to the wire giving additional insulation. The cathodically polarized Pd used as reference electrode is as described below. A piece of Pd is made the cathode and Pt is made anode. Pd is cathodically polarised by imposing external current so that hydrogen evolution takes place on its surface. As Pd has a very high affinity for hydrogen, hydrogen gets adsorbed on its surface and maintains it on the hydrogen line of Pourbaix diagram [66]. Thus the two electrode arrangement serves as a reversible hydrogen electrode. All the polarization measurements were made using a three electrode system with stainless steel specimen as working electrode, platinum as counter electrode and cathodically polarized palladium serving as reference electrode. The palladium hydrogen electrode acts as Reversible Hydrogen Electrode (RHE) with accuracy ± 10 mV.

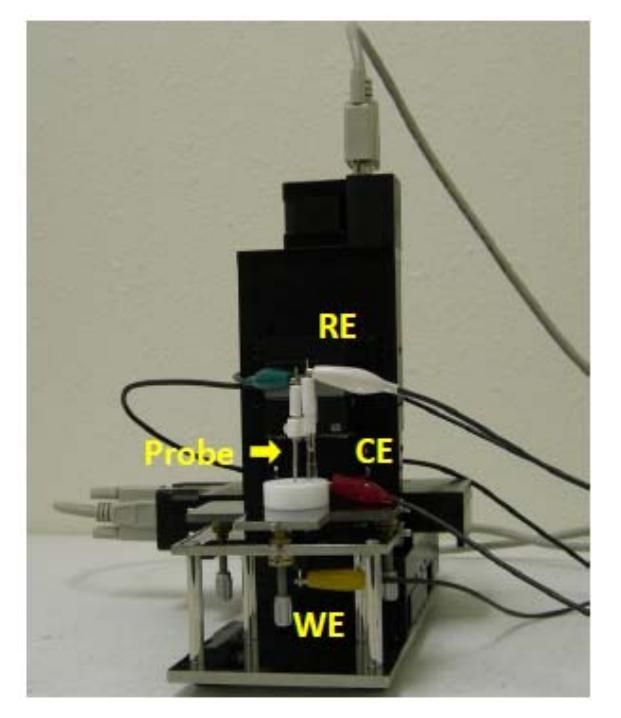
Fig. 3.3 The experimental set up of the scanning electrochemical microscope used for this study.

The measurements were performed by a CHI 900 Scanning Electrochemical Microscope (SECM) with a stepper motor driven x-, y- and z- stage. Fig. 3.3 shows the experimental set up of the scanning electrochemical microscope used for the present study. The SECM was used with a mediator in the feedback mode and variations in current due to heterogeneities were plotted versus the tip position. An Ag-AgCl reference electrode and a Pt wire as the counter electrode were used. The tip for SECM measurements was a glass insulated, disk-shaped platinum microelectrode with a 10 micrometer diameter Pt wire. The tip was polished with 0.05 micrometer alumina and cleaned with distilled water prior to each experiment. Tip potential was set at + 0.7 V Ag-AgCl and cold mounted polished samples with electrical connections (area 1 cm²) were press fitted, facing upwards in an electrochemical cell made of Teflon. Borate buffer (0.05M H₃BO₃ + 0.075M Na₂B₄O₇.10H₂O) with KI (10 mM) added to the cell so as to cover the sample with a 2-3 mm of solution layer. All solutions were prepared by reagent grade chemicals and distilled water. Also, a quiet time of 15 min was provided before each scan to stabilize the current values at the applied substrate potentials. Increment time was 0.025 s and increment distance was 1 micrometer [67-68].

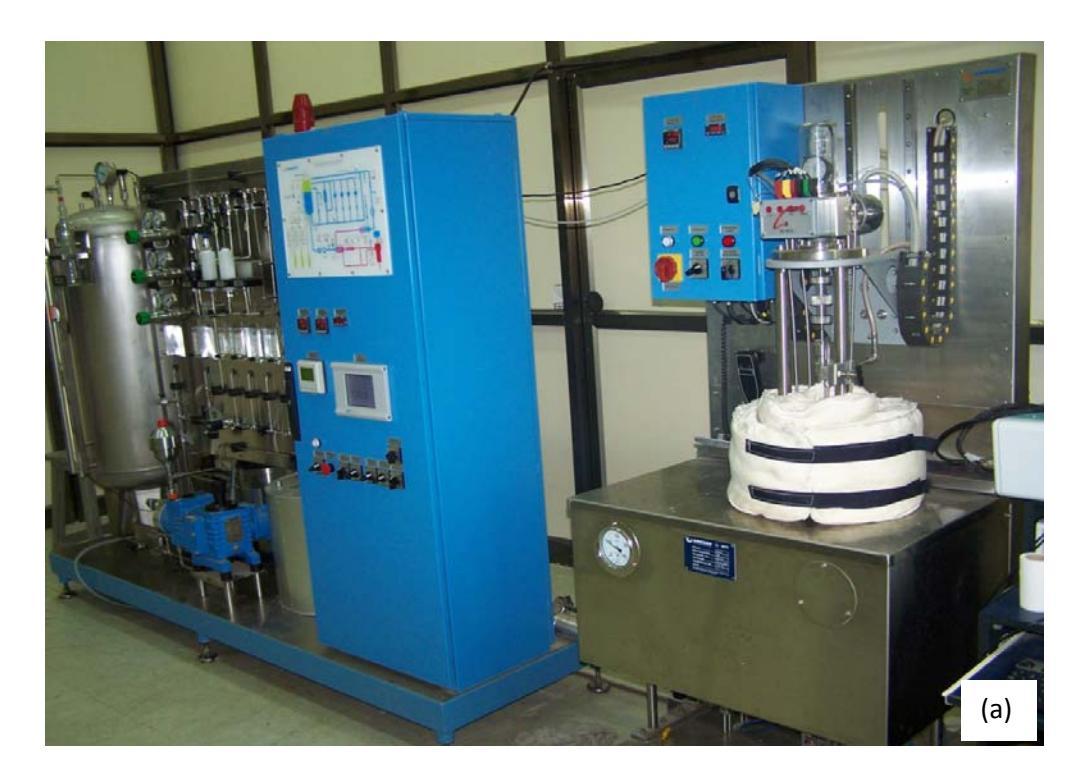
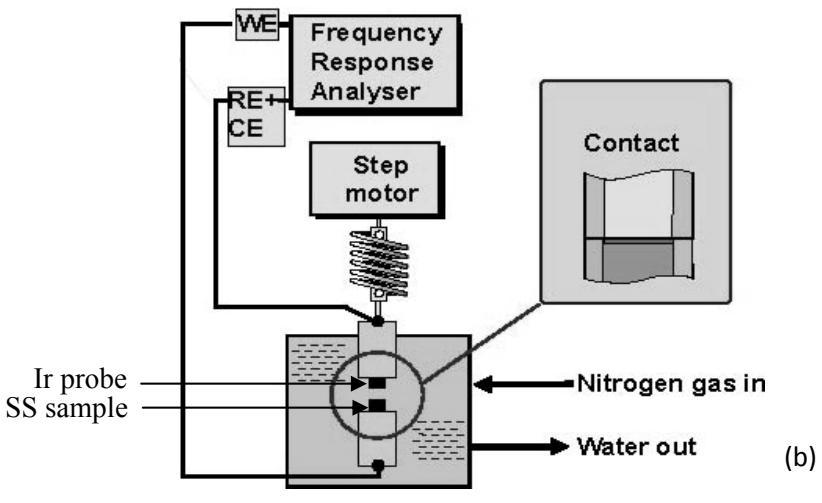
Fig. 3.4 (a) The experimental set up showing the recirculation loop connected to an autoclave used for oxidation studies at high temperature and high pressure (HTHP) conditions and (b) schematic showing controlled distance electrochemistry set up inside the autoclave.

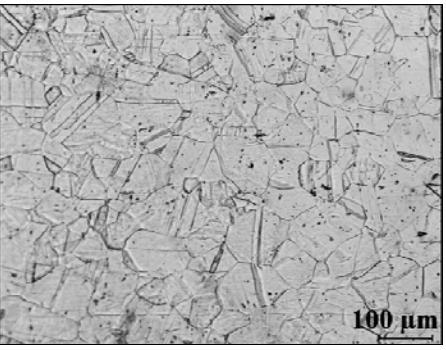
Fig. 4.1 Microstructure of solution annealed 304L stainless steel.

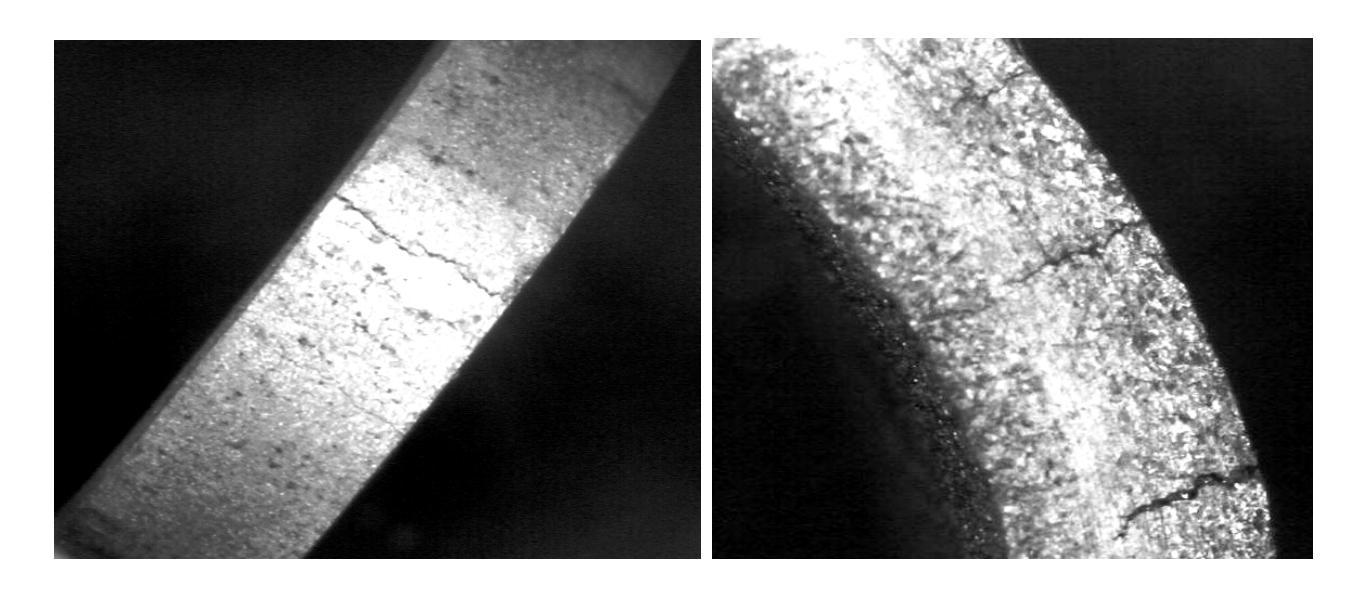
Fig.4.2 Stress corrosion cracks on the (a) surface and (b) cross section of constant strain solution annealed 304L stainless steel sample exposed to 1 M HCl at room temperature for 7 days .

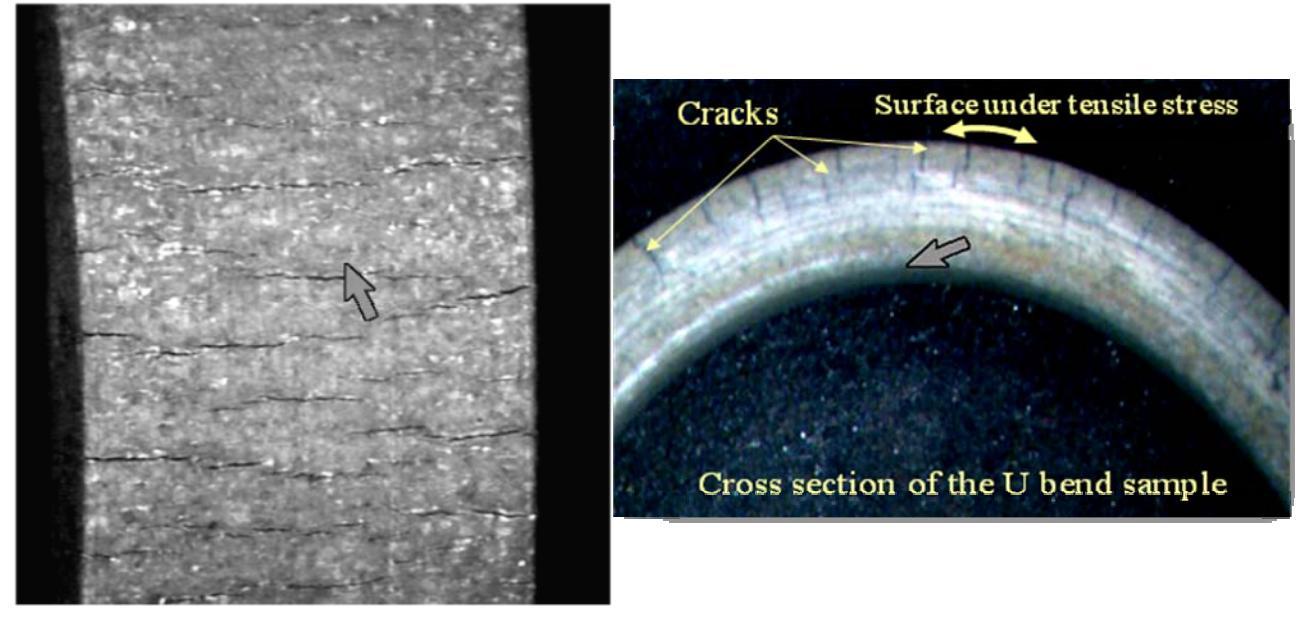
Fig. 4.3 Stress corrosion cracks on the (a) surface and (b) cross-section of machined 304L stainless steel sample exposed to 1 M HCl solution at room temperature for 48 h.

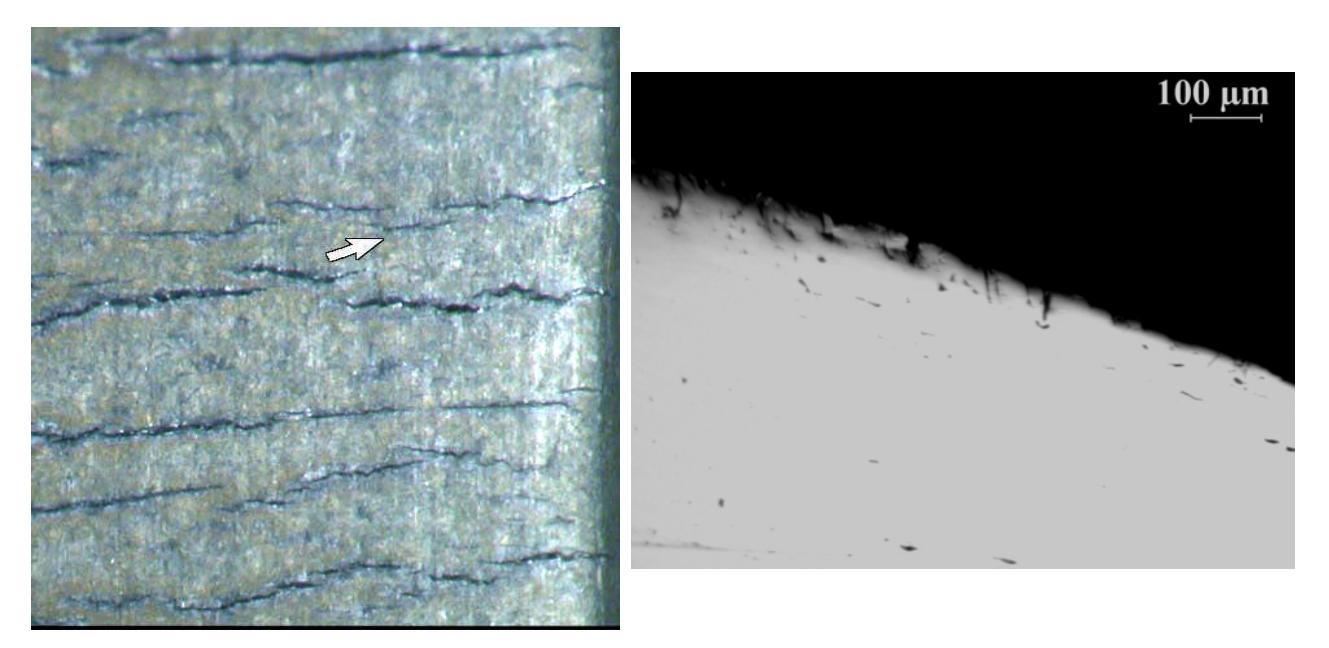
Fig. 4.4 Stress corrosion cracks on the (a) surface and (b) cross section of ground 304L stainless steel sample exposed to 1 M HCl solution at room temperature for 48 h.

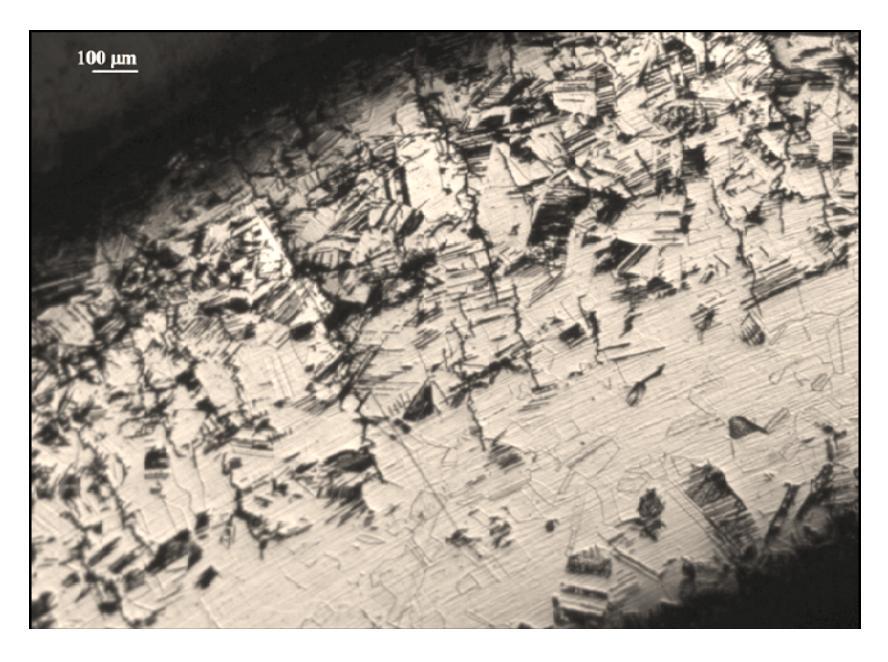
Fig. 4.5 Stress corrosion cracks and extensive attack along slip bands on the cross section of constant strain cold worked 304L stainless steel exposed to 1M HCl at room temperature for 4 days.

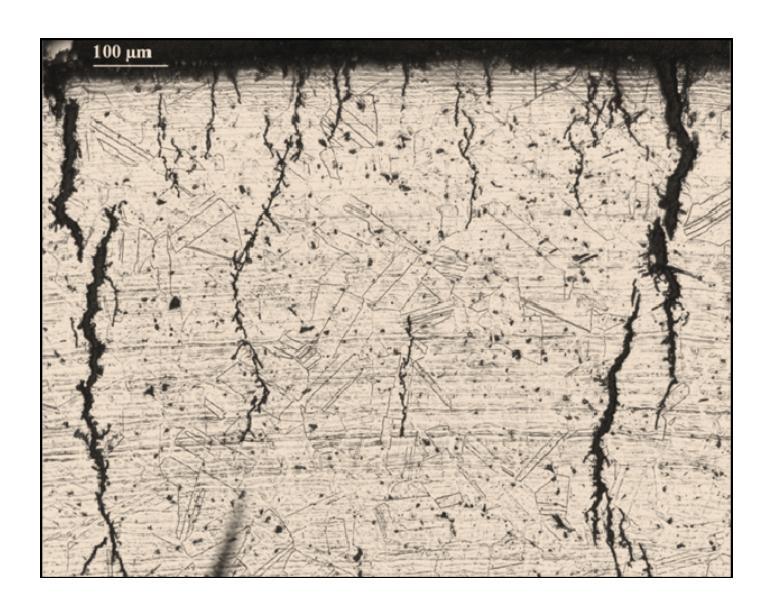
Fig.4.6 Microstructure of the cross section of the U bend sample of solution annealed 304L stainless steel exposed to 1M HCl at room temperature for 7 days showing numerous cracks.

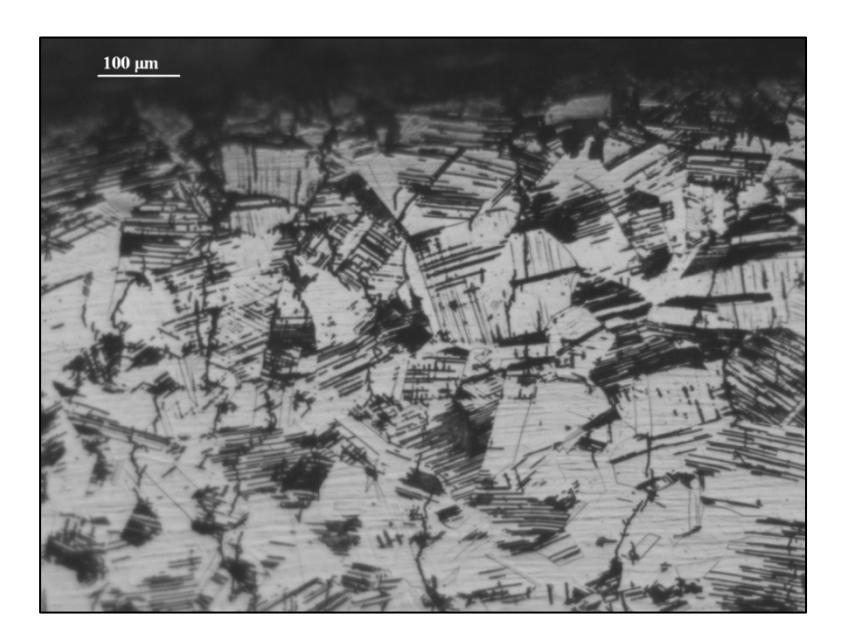
Fig. 4.7 Magnified view of the microstructure of the cross section of the U bend sample of cold worked 304L stainless steel exposed to 1M HCl at room temperature for 170 h extensive attack at the slip bands together with stress corrosion cracks.

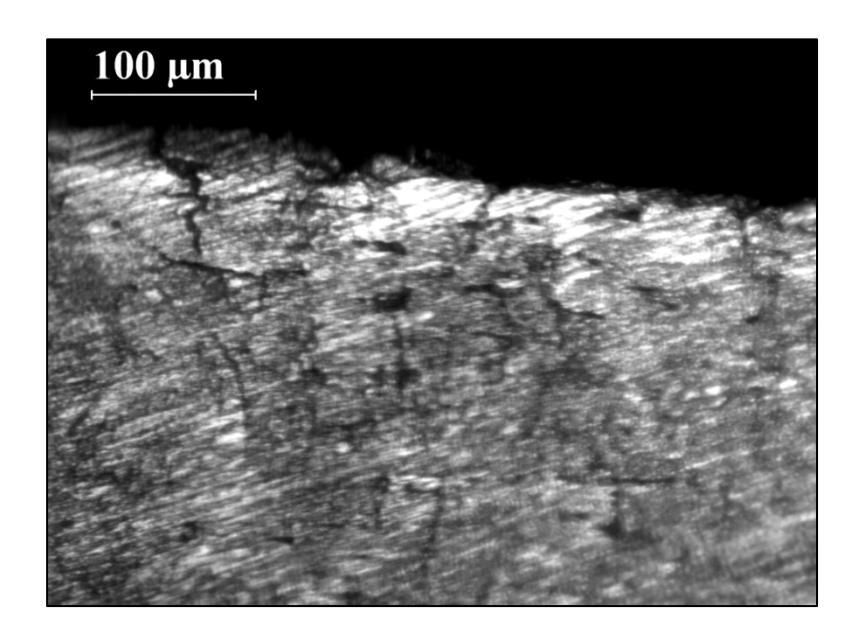
Fig 4.8 Microstructure of the cross section of the U bend sample of machined 304L stainless steel exposed to 1M HCl at room temperature for 170 h showing stress corrosion cracks.

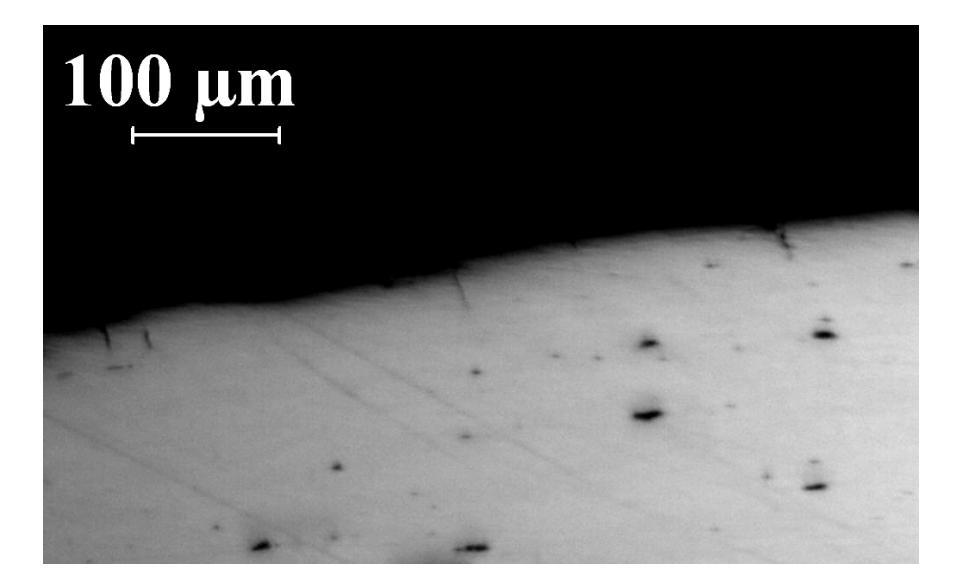
Fig 4.9 Microstructure of the cross section of the U bend sample of ground 304L stainless steel exposed to 1M HCl at room temperature for 170h showing stress corrosion cracks.

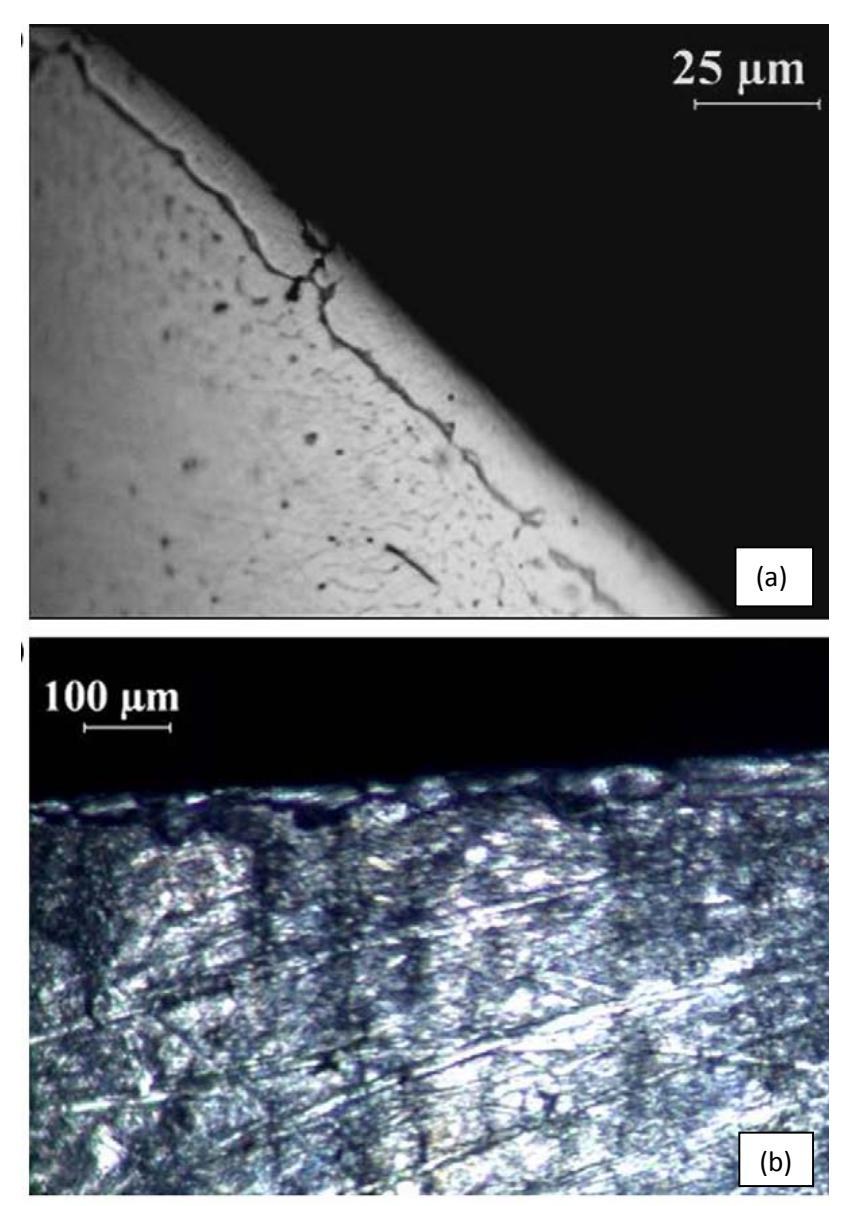
Fig. 4.10 Optical micrographs of cross-section of 304L stainless steel in unstressed condition after exposure to 1M HCl at ambient temperature, (a) machined and (b) ground condition.

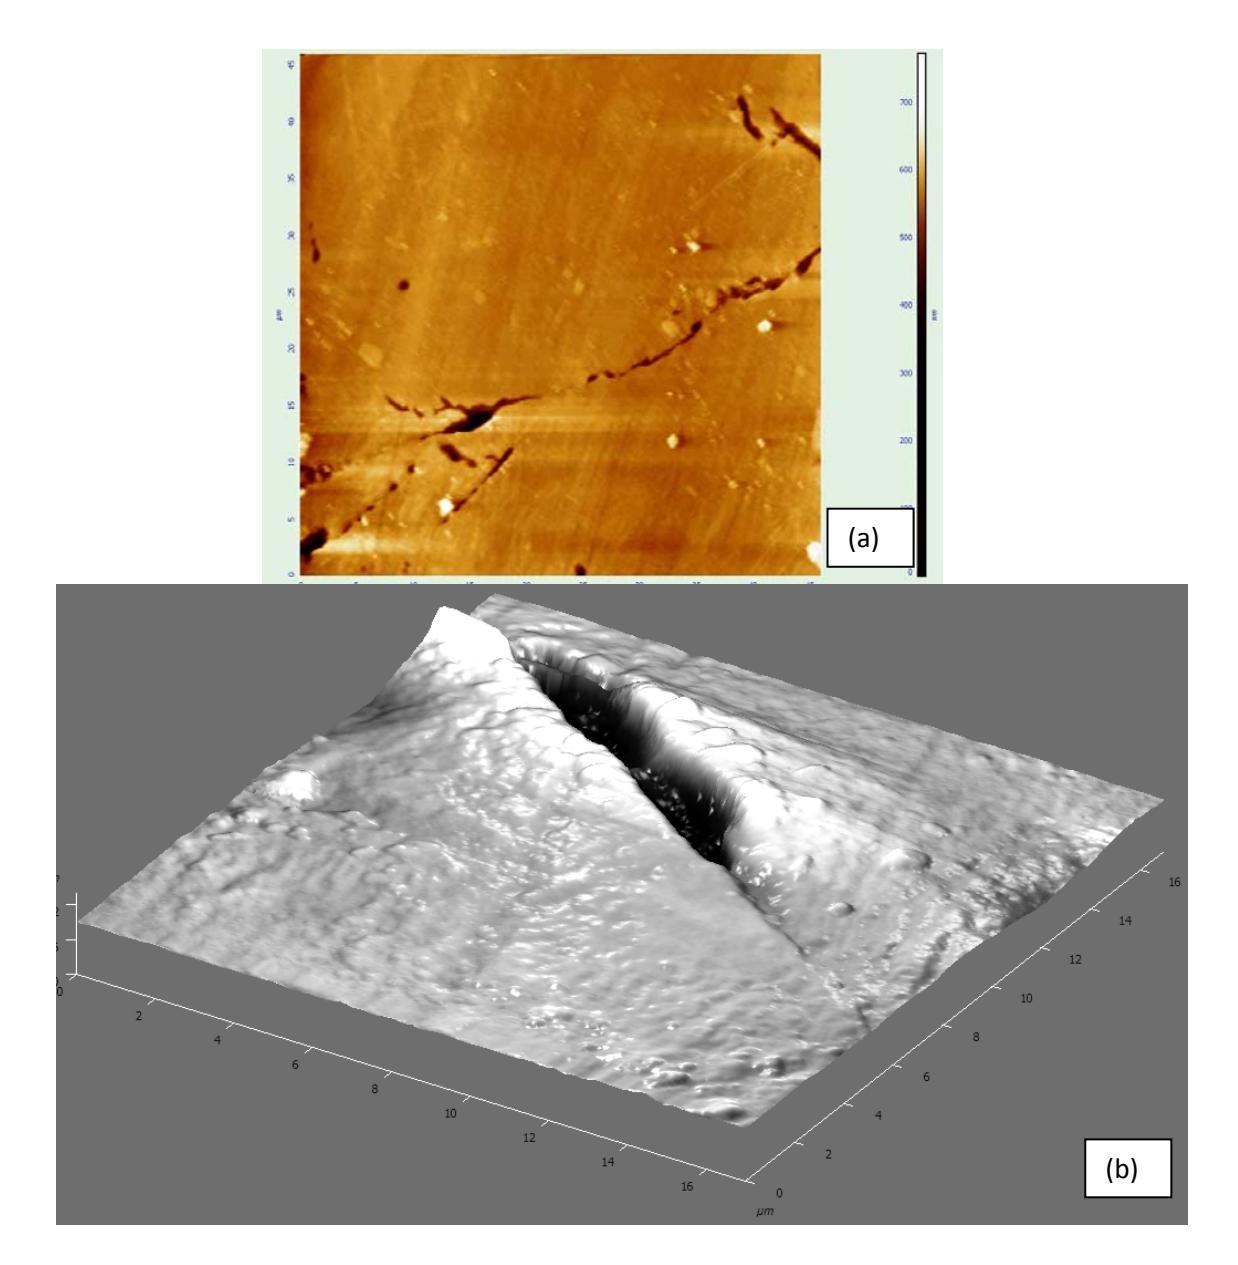
Fig. 4.11 AFM image of the cold worked sample after exposure to 1M HCl at room temperature (a) fine crack showing branching characteristic of chloride SCC and (b) 3D image of a crack tip.

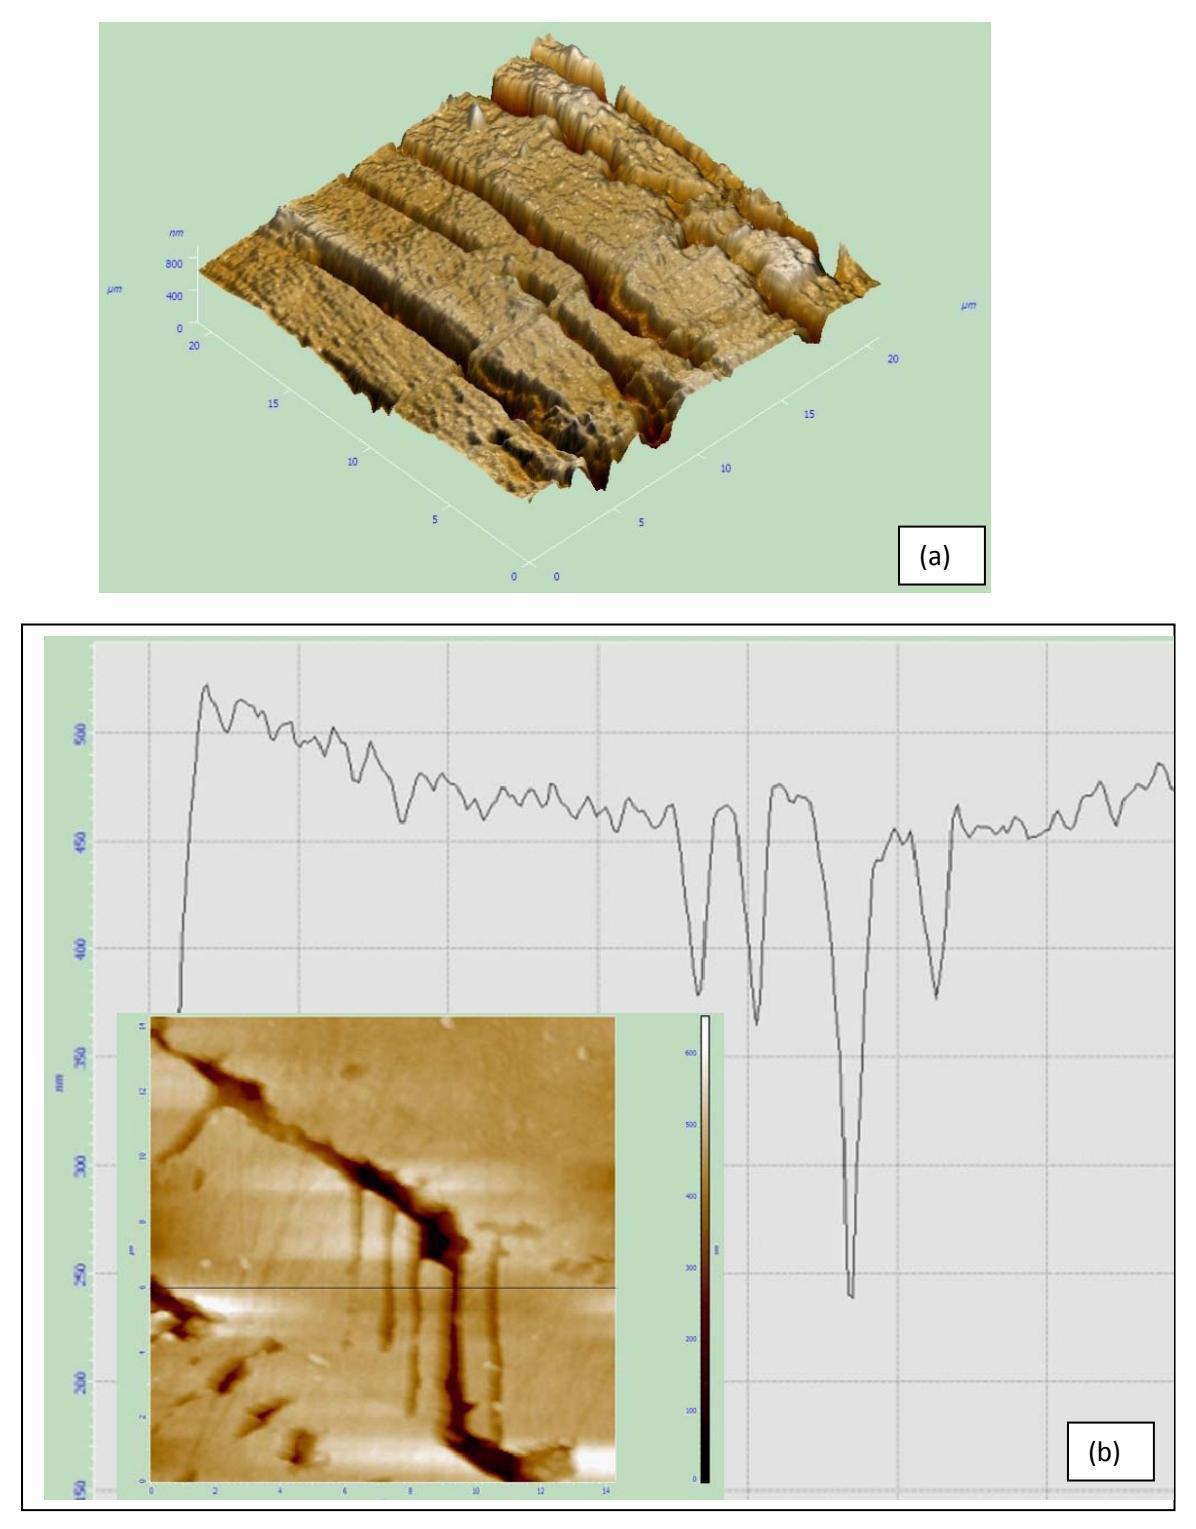
Fig. 4.12 AFM image of the cold worked sample after exposure to 1M HCl at room temperature (a) 3D image of heavily attacked slip lines (b) 2D image showing the crack path and attacked slip bands with line depth analysis.

propagation in cold worked austenitic stainless steel as is clear from Fig. 4.12 (a) and (b) respectively which are microstructures in un-etched condition as obtained after exposure to 1M HCl at room temperature for 96 h.

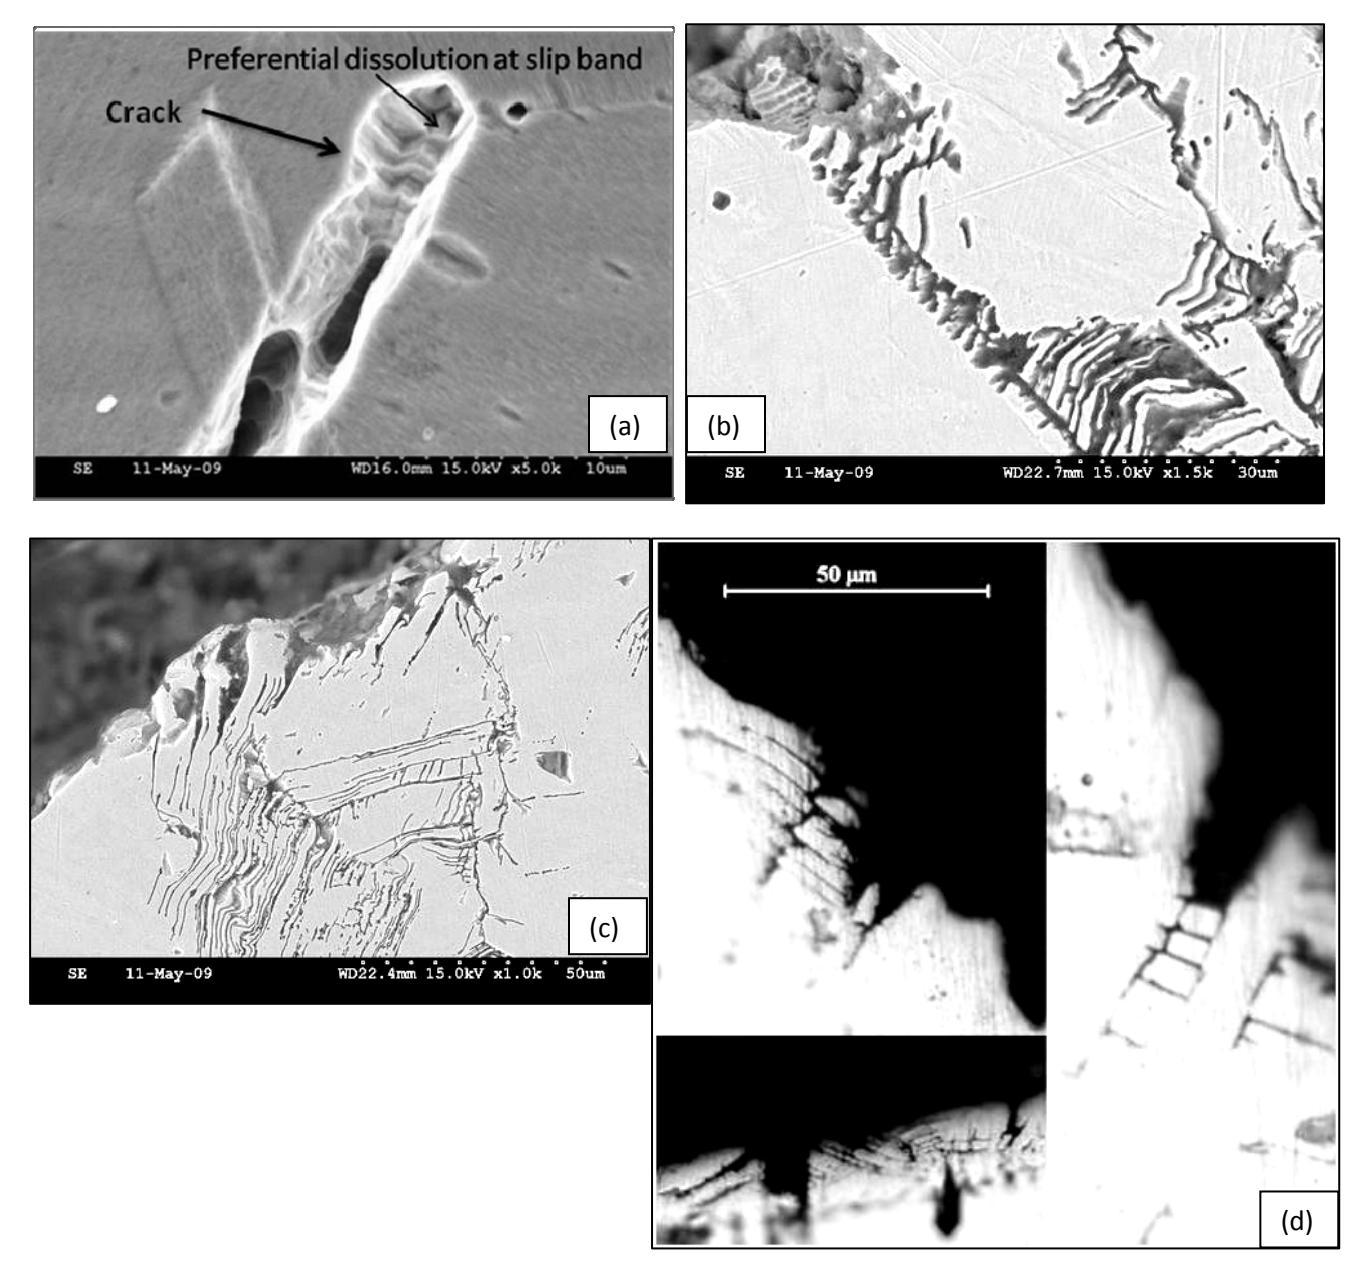
Fig. 4.13 SEM images of the cross section of cold worked 304L stainless steel exposed to 1M HCl solution for 96 h showing different modes of initiation of attack: (a) preferential dissolution at slip band, (b) corrosion tunneling along slip bands, (c) attack along the slip bands and (d) formation of pit followed by attack along slip bands.
