Effect of Surface Working Operations on Electrochemical Corrosion and Susceptibility to Stress Corrosion Cracking of 304L Stainless Steel

A thesis submitted to the

Doctor of Philosophy

Homi Bhabha National Institute

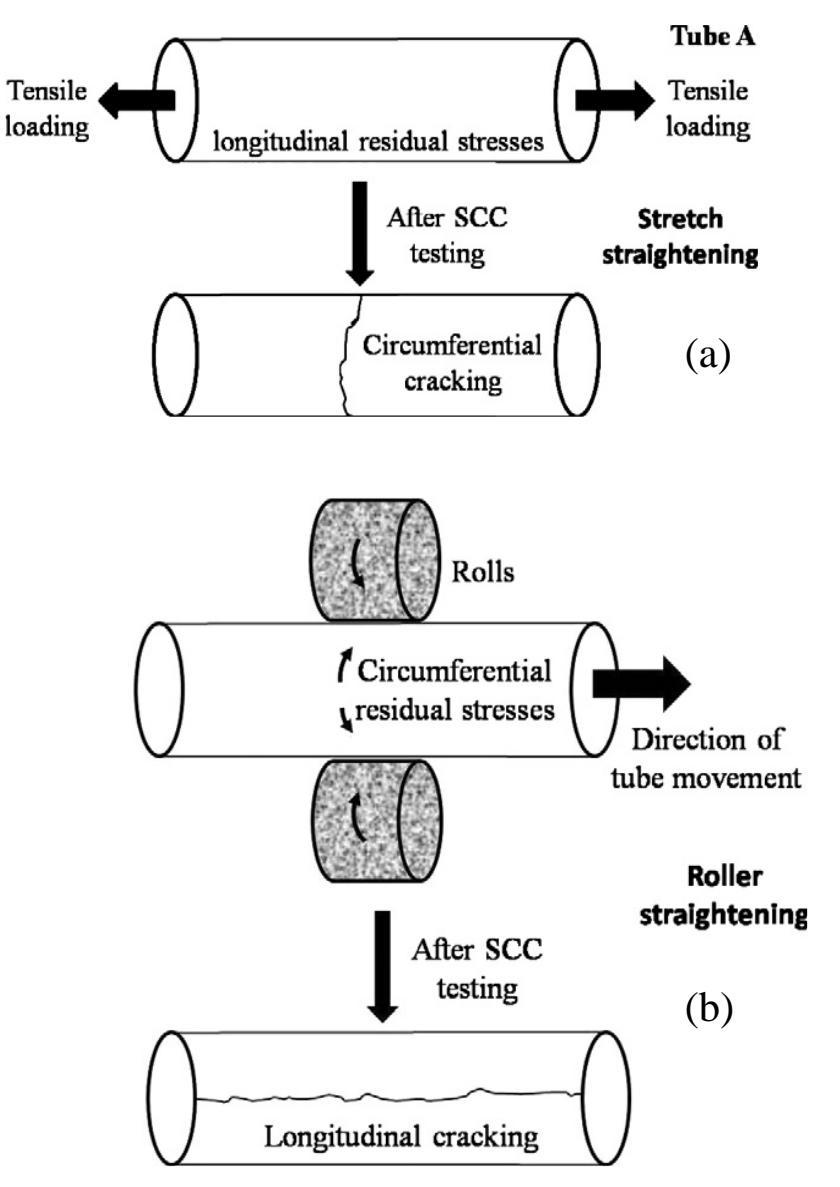
Fig. 5.2 Schematic of (a) stretch straightening and (b) roller straightening technique of industrially fabricated tubes and resultant direction of cracking in SCC test.

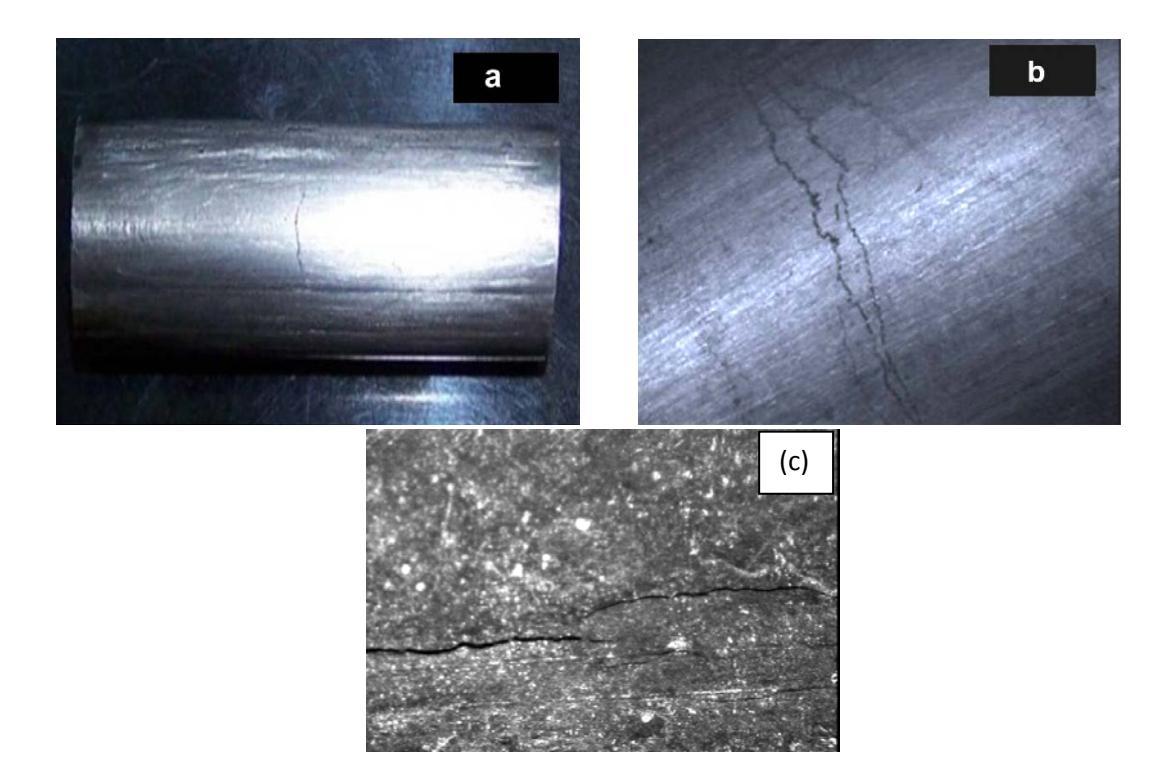
Fig. 5.3 (a) SCC of Tube A after 16 h in boiling magnesium chloride test, (b) after 24 h exposure and (c) stereo micrograph of the cracks showing small cracks growing and coalescing to produce a single long crack.

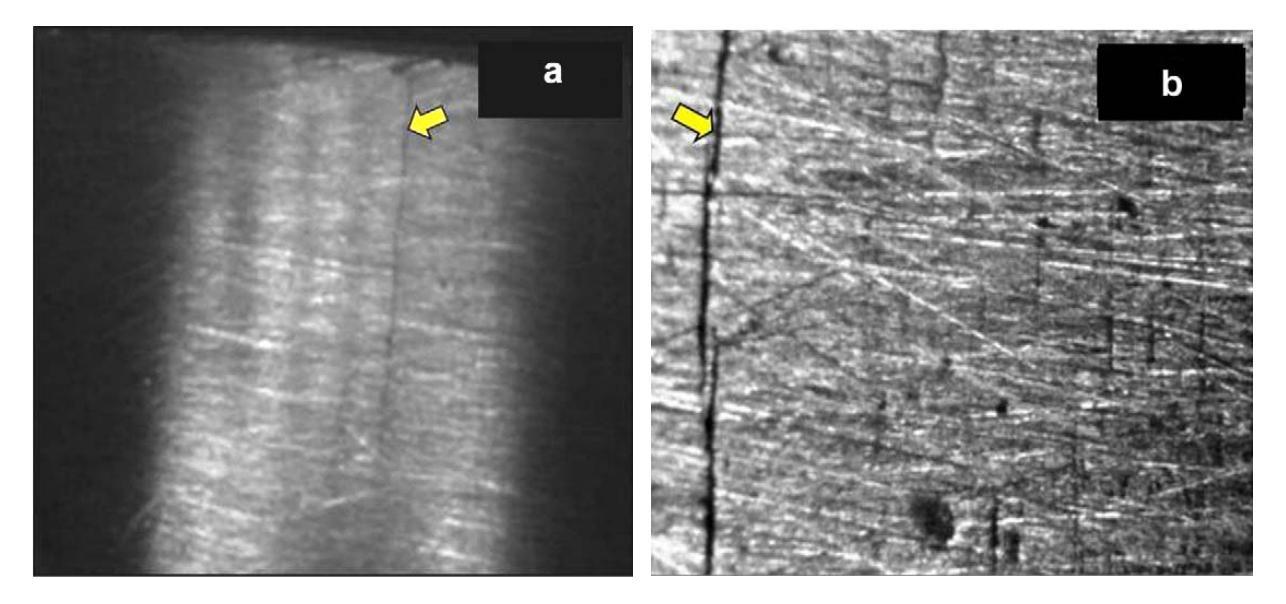
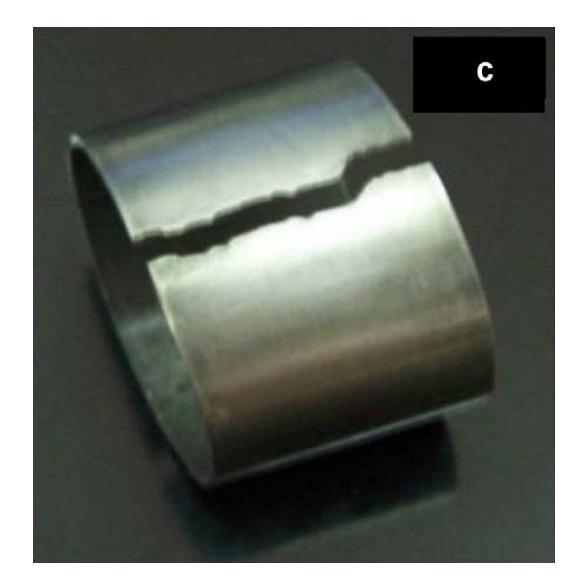
Fig. 5.4 As received tubes exposed to boiling magnesium chloride test for different durations, (a) stereo microscopic images after 10 h of exposure showing a single fine longitudinal crack in the high stress, Tube B, (b) stereo microscopic image showing number of fine cracks in the longitudinal direction and (c) completely failed Tube B after 16 h exposure.

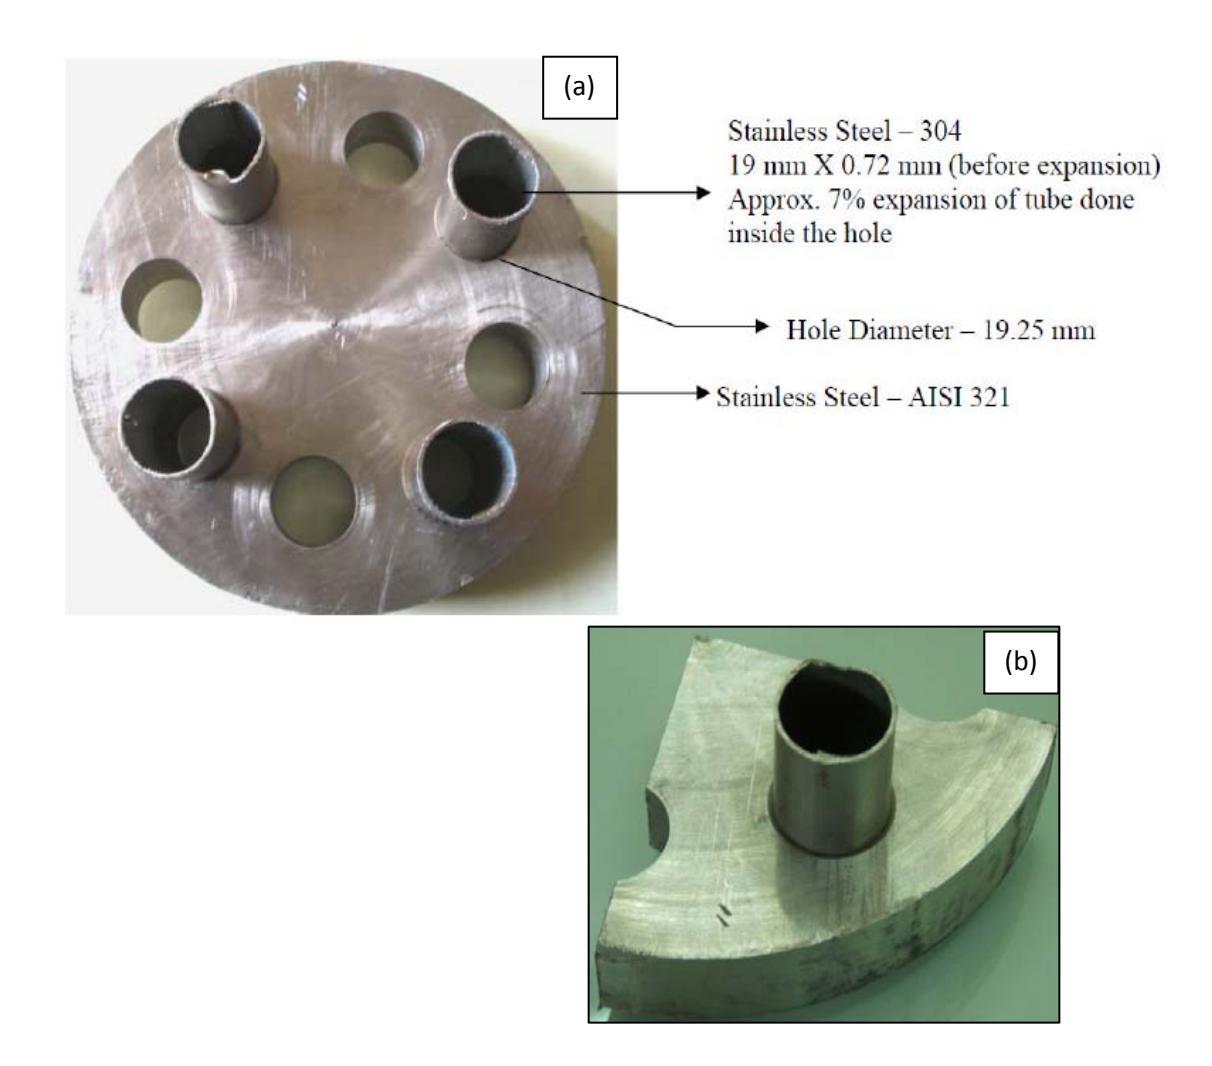
Fig.5.5 (a) As received tube-tube sheet roll expansion joints of 304 stainless steel having very high residual stresses and (b) Sample cut out for ASTM G36 test.

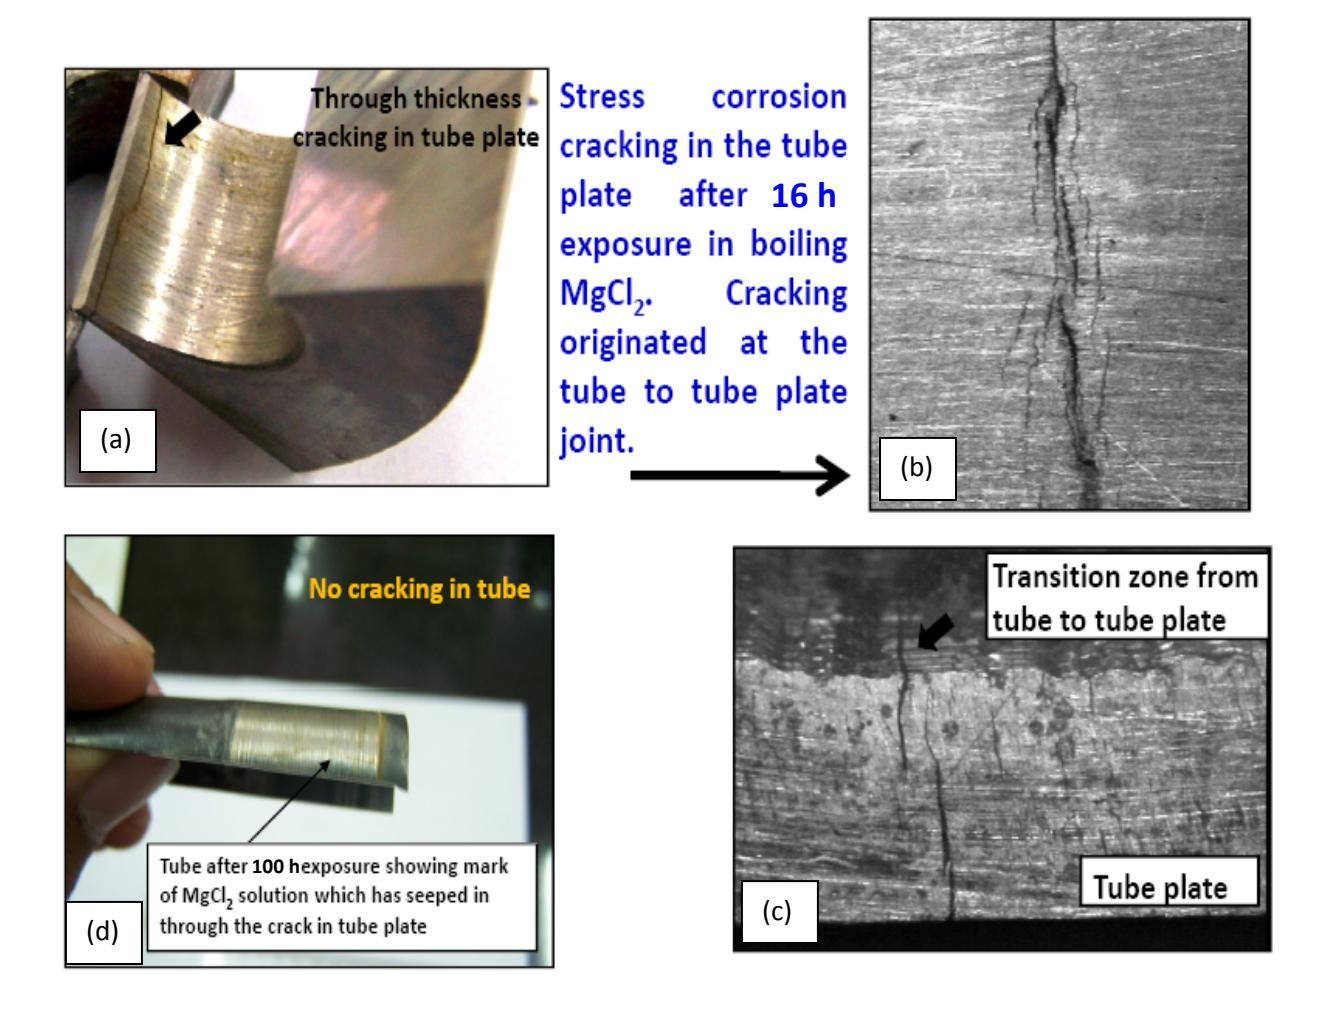
Fig. 5.6 (a) Tube–tube sheet joint after exposure to boiling magnesium chloride test, (b) through thickness cracking in the tube sheet, (c) transgranular cracking in the transition zone from tube to tube sheet (planar view) and (d) no cracking on the tube surface.

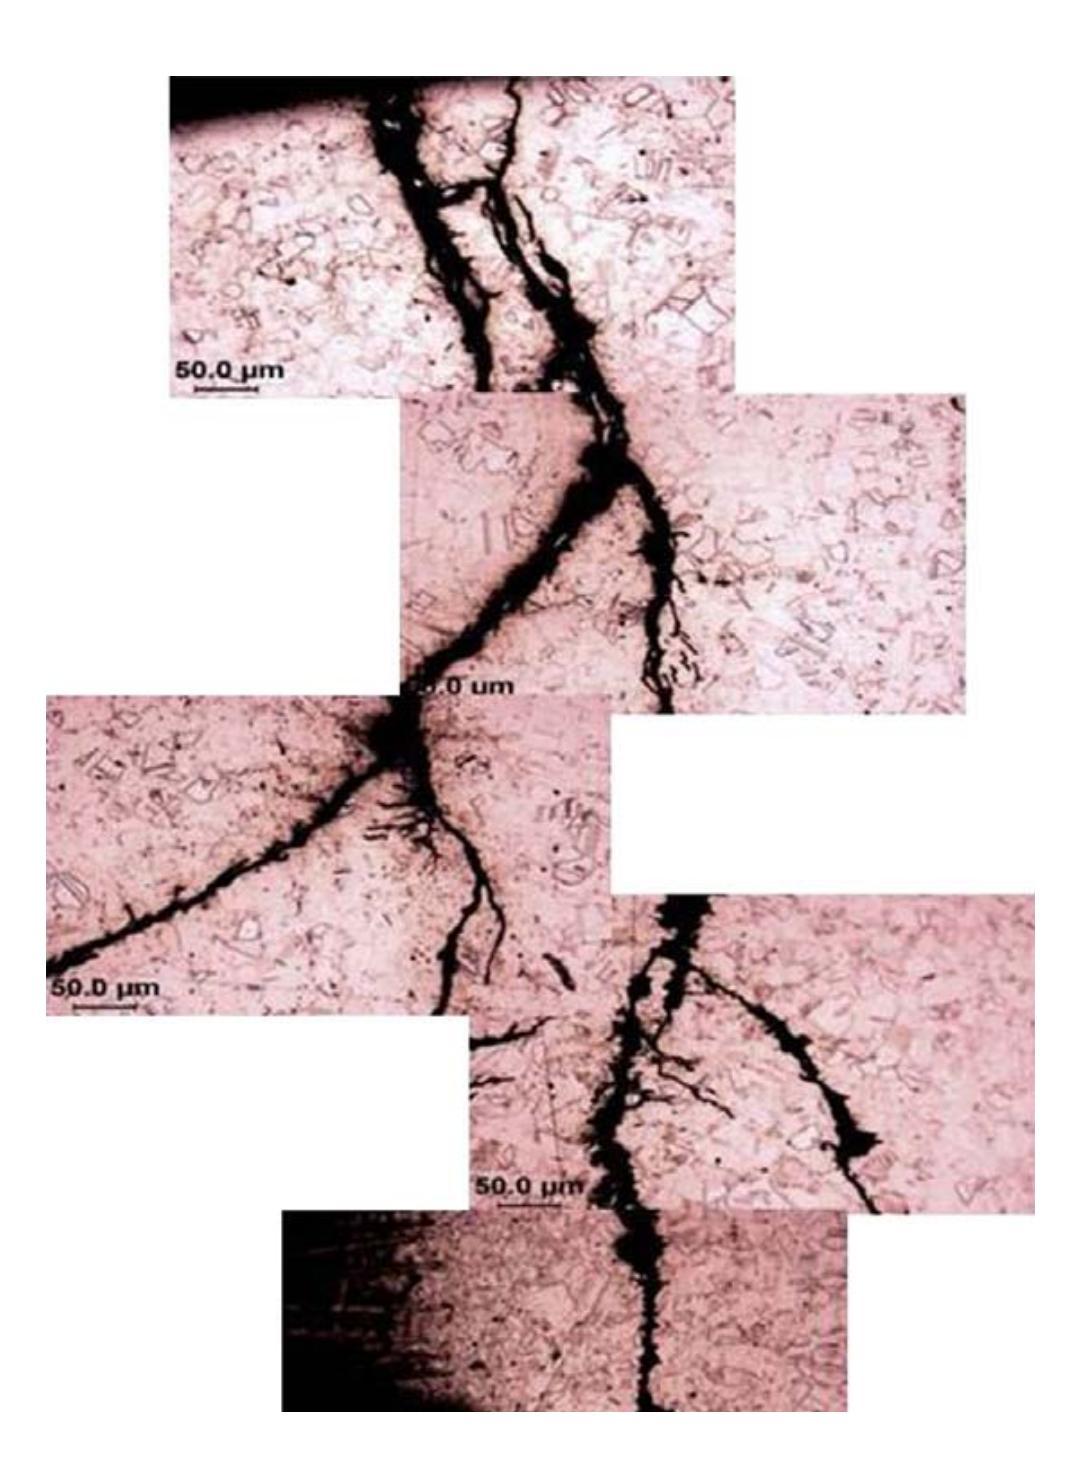
Fig. 5.7 Optical microstructure of transgranular SCC along the thickness of the tube sheet showing highly branched cracking resembling 'lightning bolt' nature of SCC.

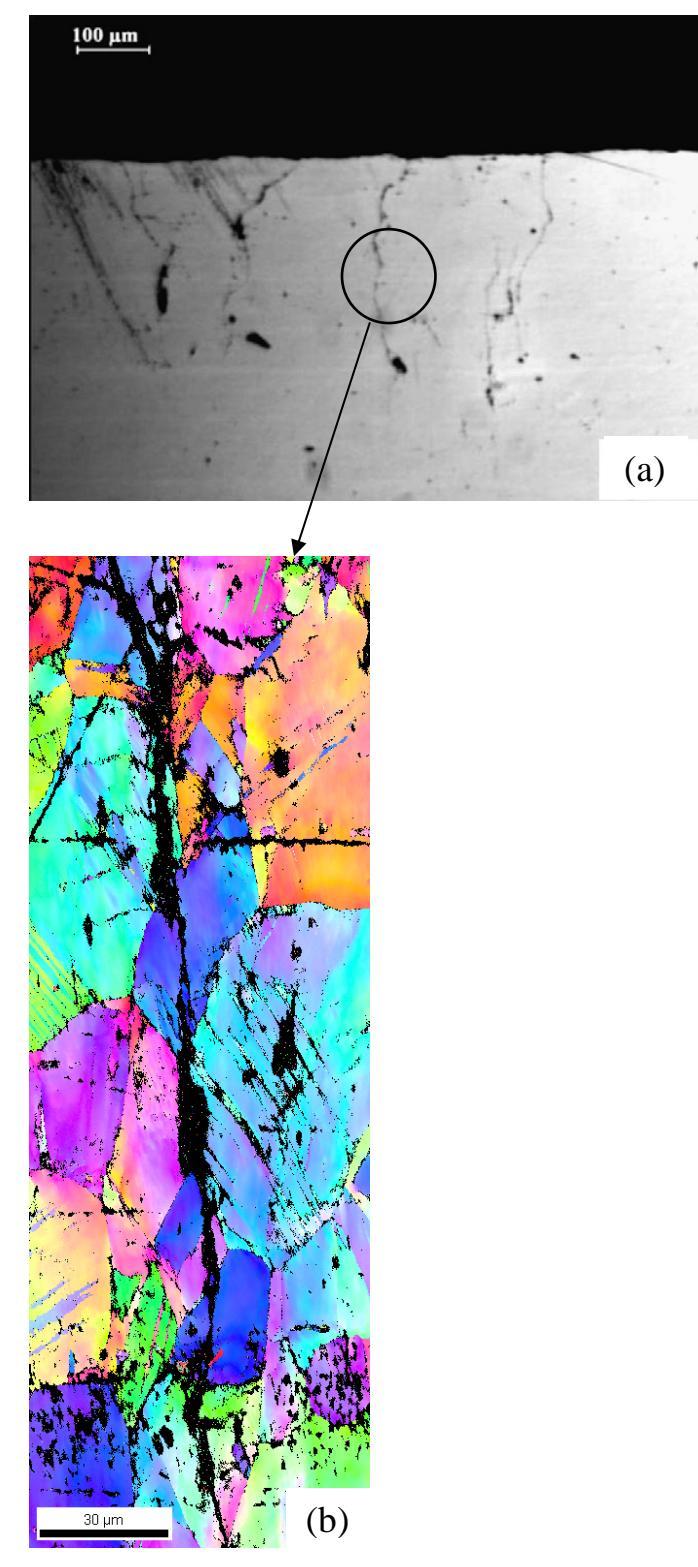
Fig. 5.8 (a) SCC on the cross section of the strip of machined 304 L stainless steel and (b) transgranular nature of SCC produced on exposure to boiling $MgCl_2$ clearly revealed by orientation imaging microscopy.

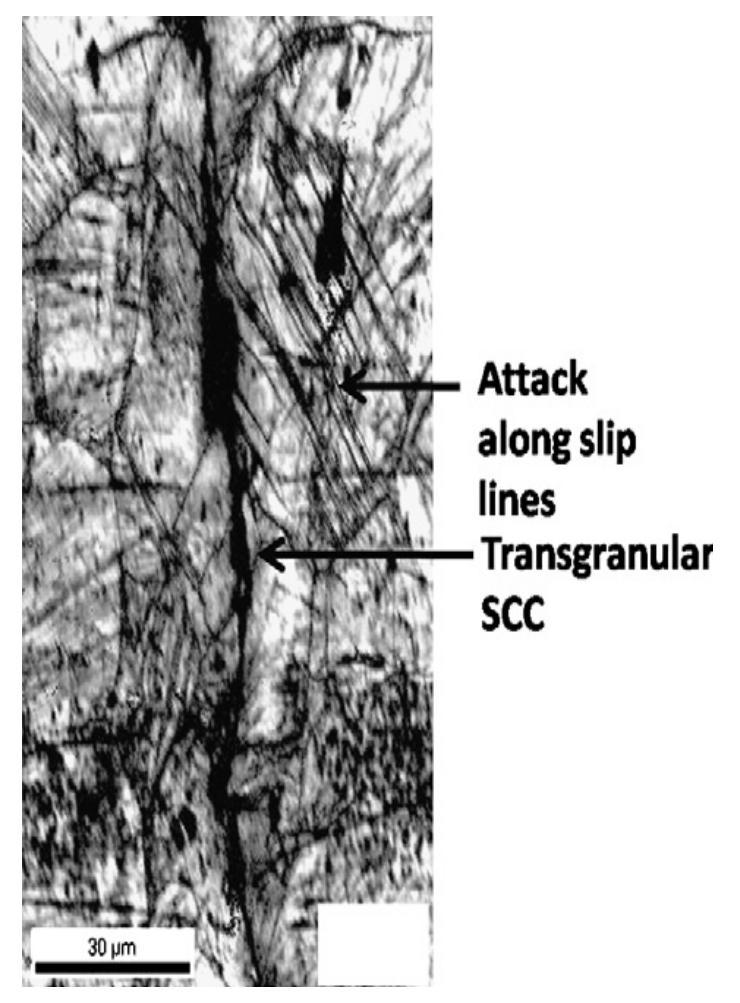
Fig. 5.9 EBSD image showing high density of slip bands surrounding the stress corrosion crack.

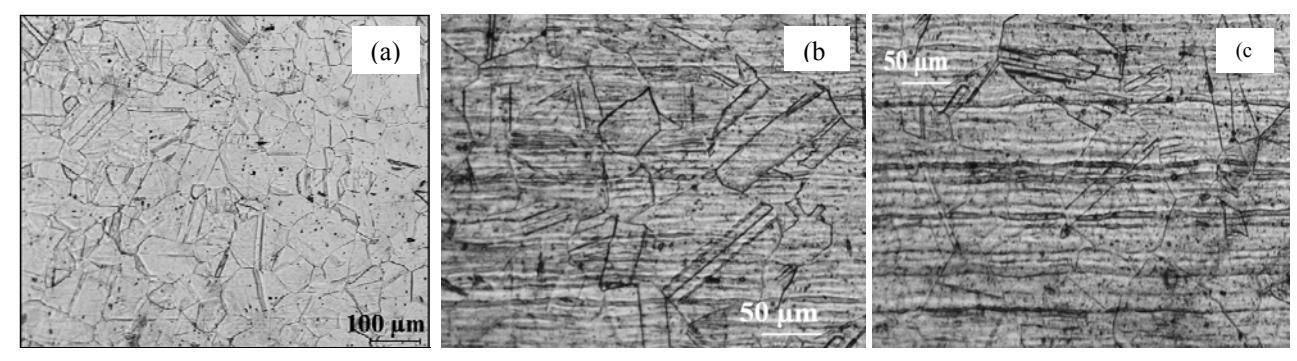
Fig. 6.1 Microstructure of 304L stainless steel in (a) solution annealed condition (b) machined condition and (c) ground condition.

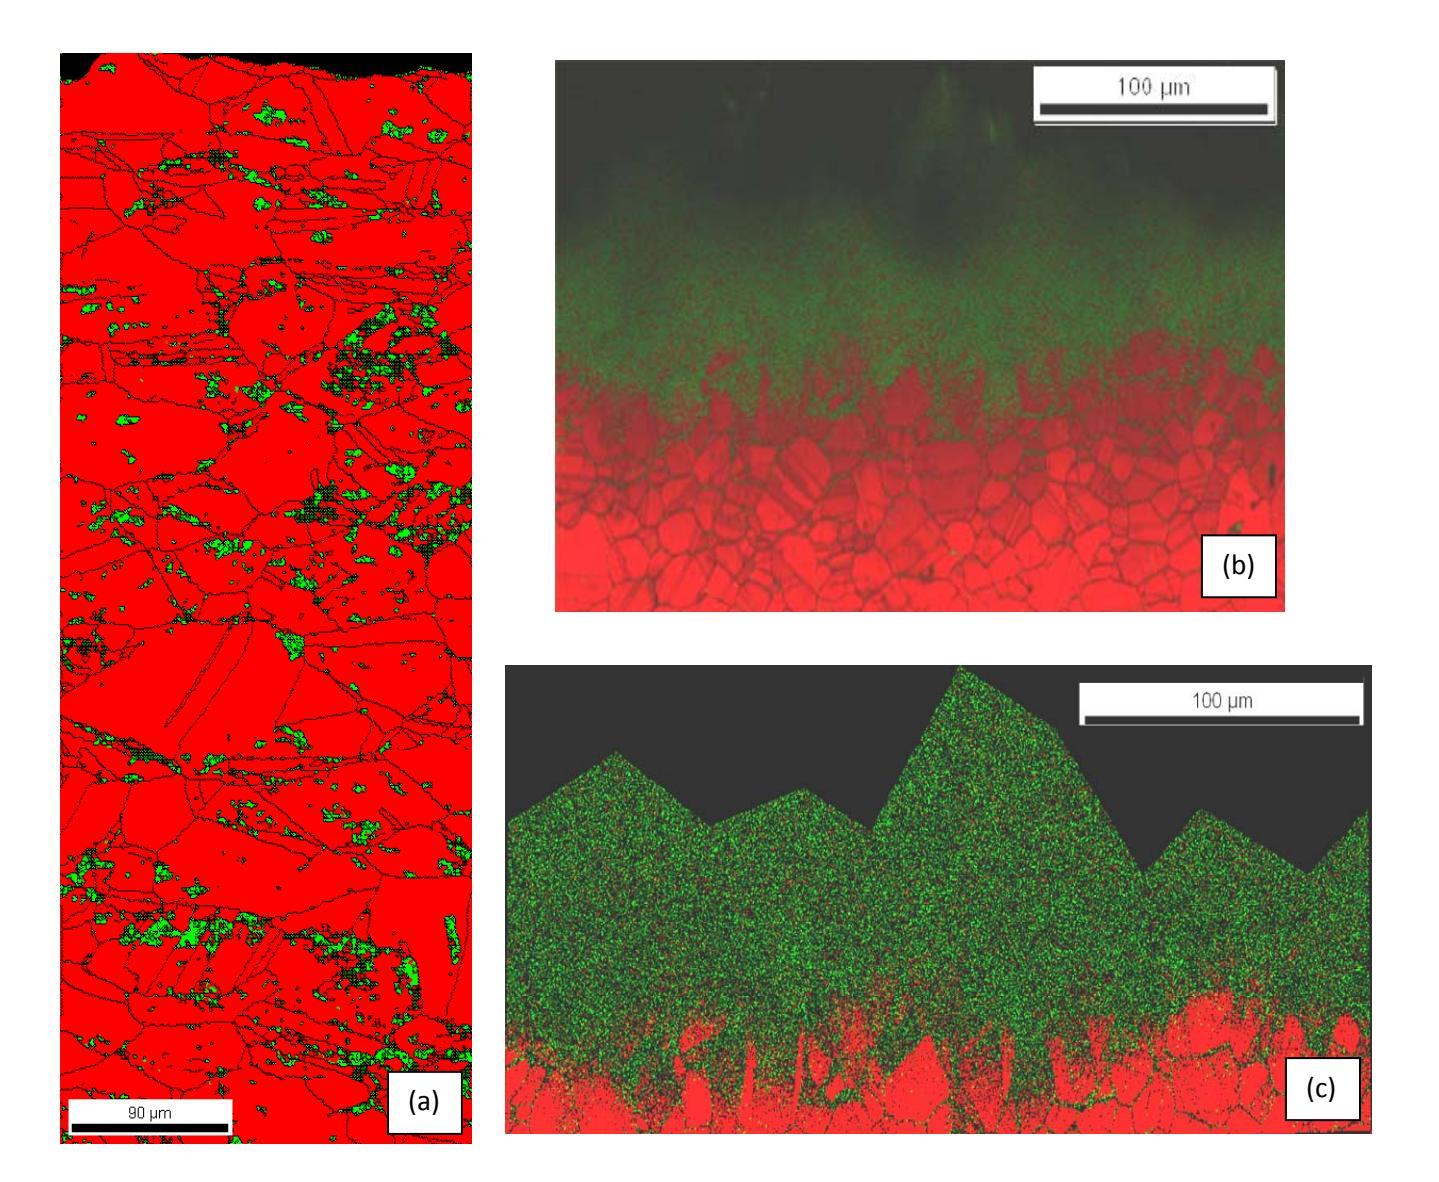
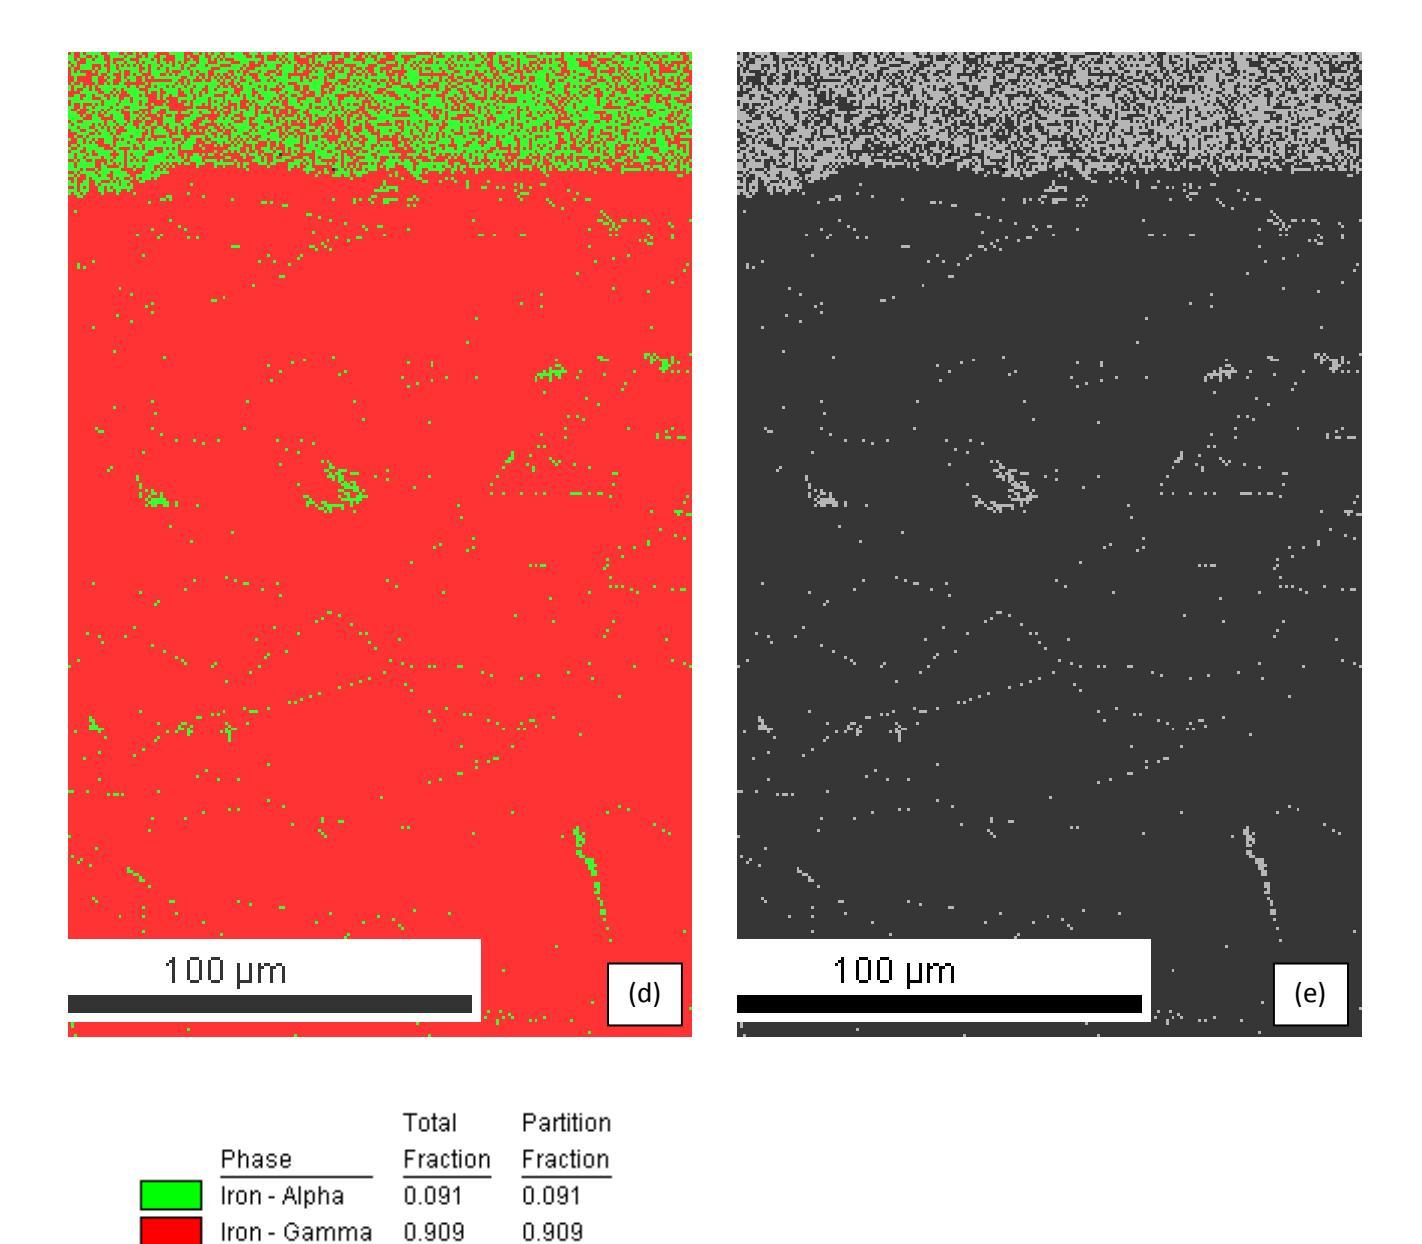
Fig. 6.3 Phase contrast maps of the cross section of (a) cold rolled sample, (b) machined sample, (c) magnified image of the near surface region of the machined sample (d) ground and (e) grey scale image (for better contrast) of ground sample highlighting the difference in distribution of martensite produced due to cold rolling and due to surface working operations on 304L stainless steel.

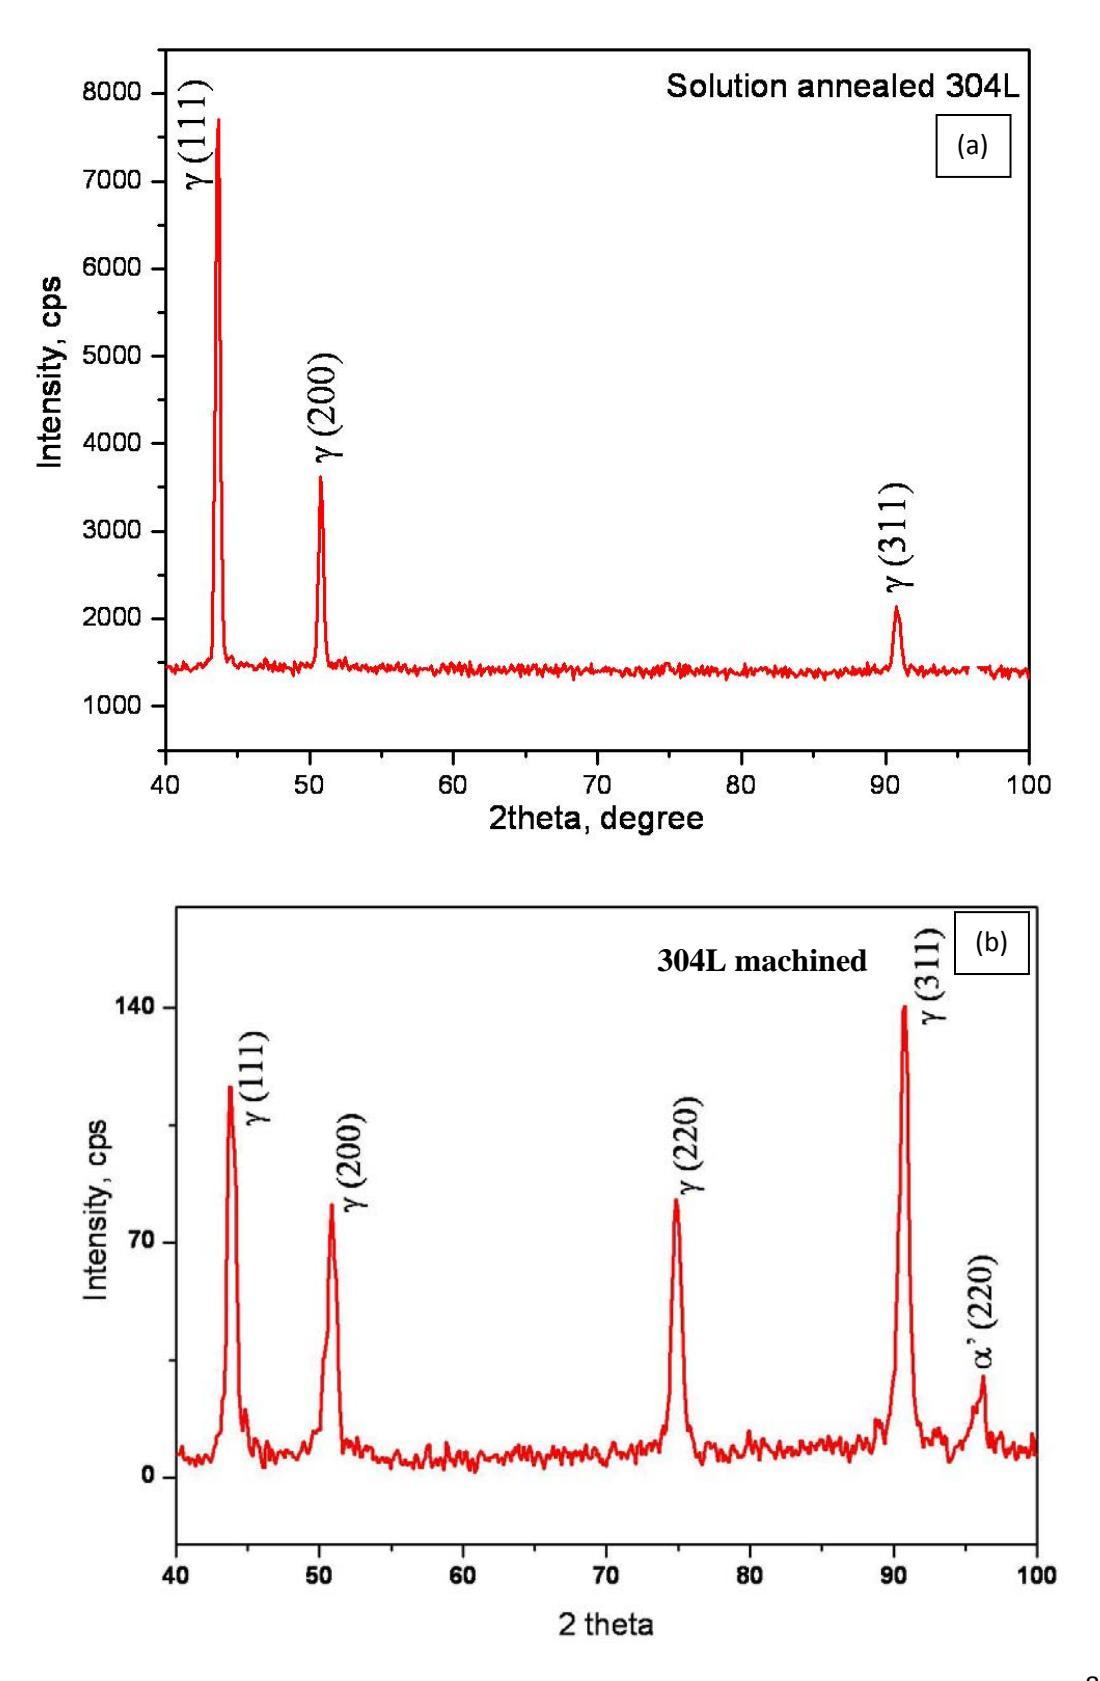
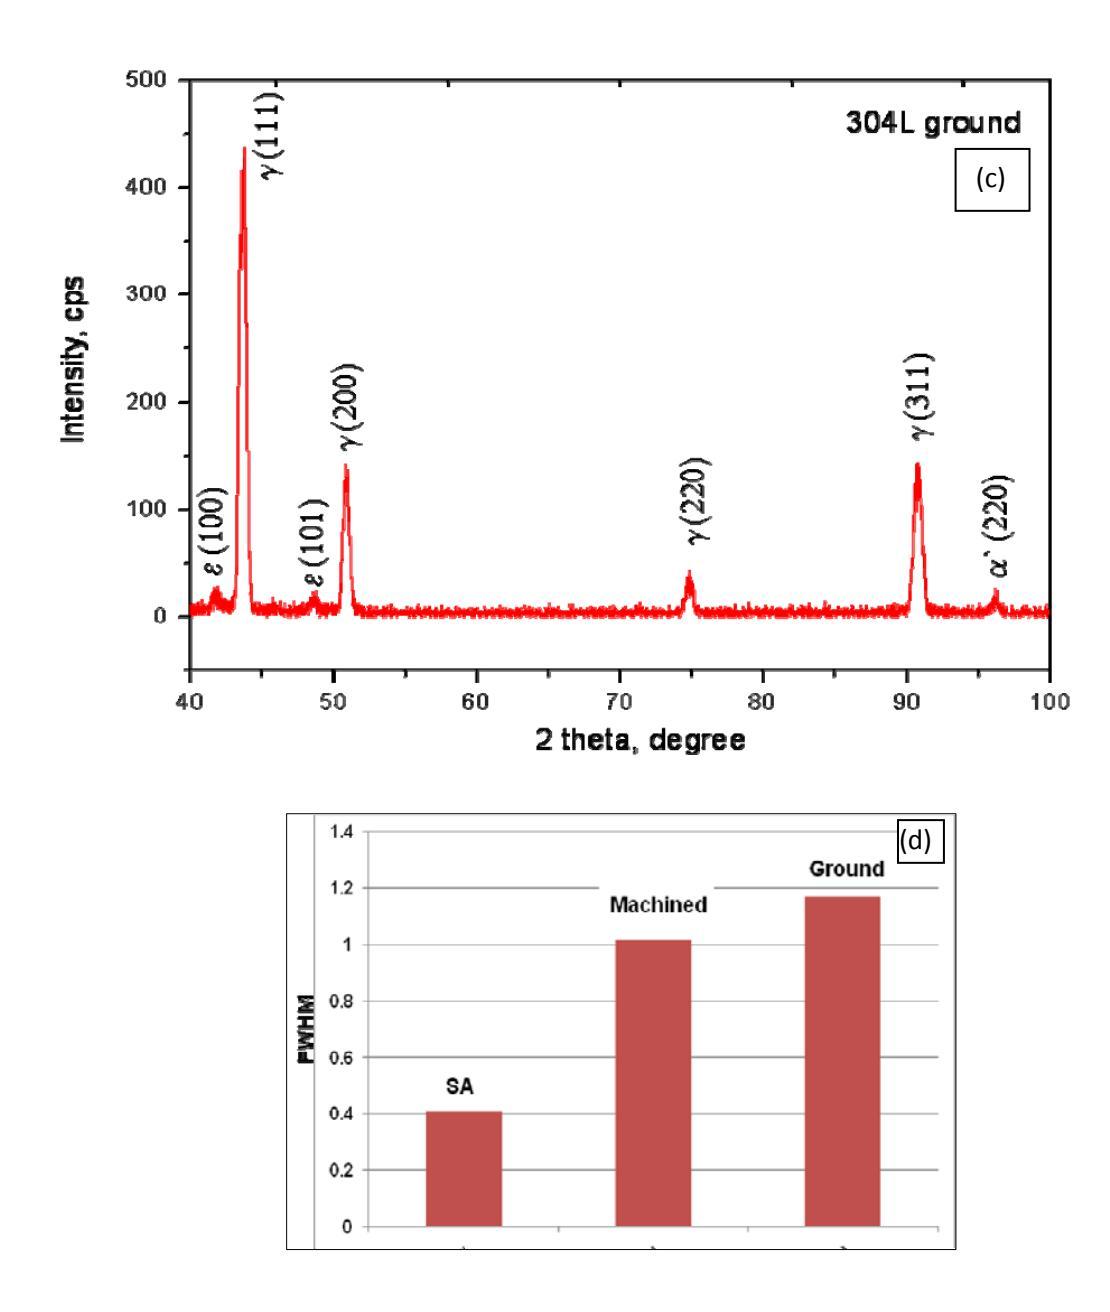
Fig. 6.4 The XRD spectra of 304L stainless steel in (a) solution annealed, (b) machined and (c) ground condition and (d) bar chart showing FWHM for the three different conditions.

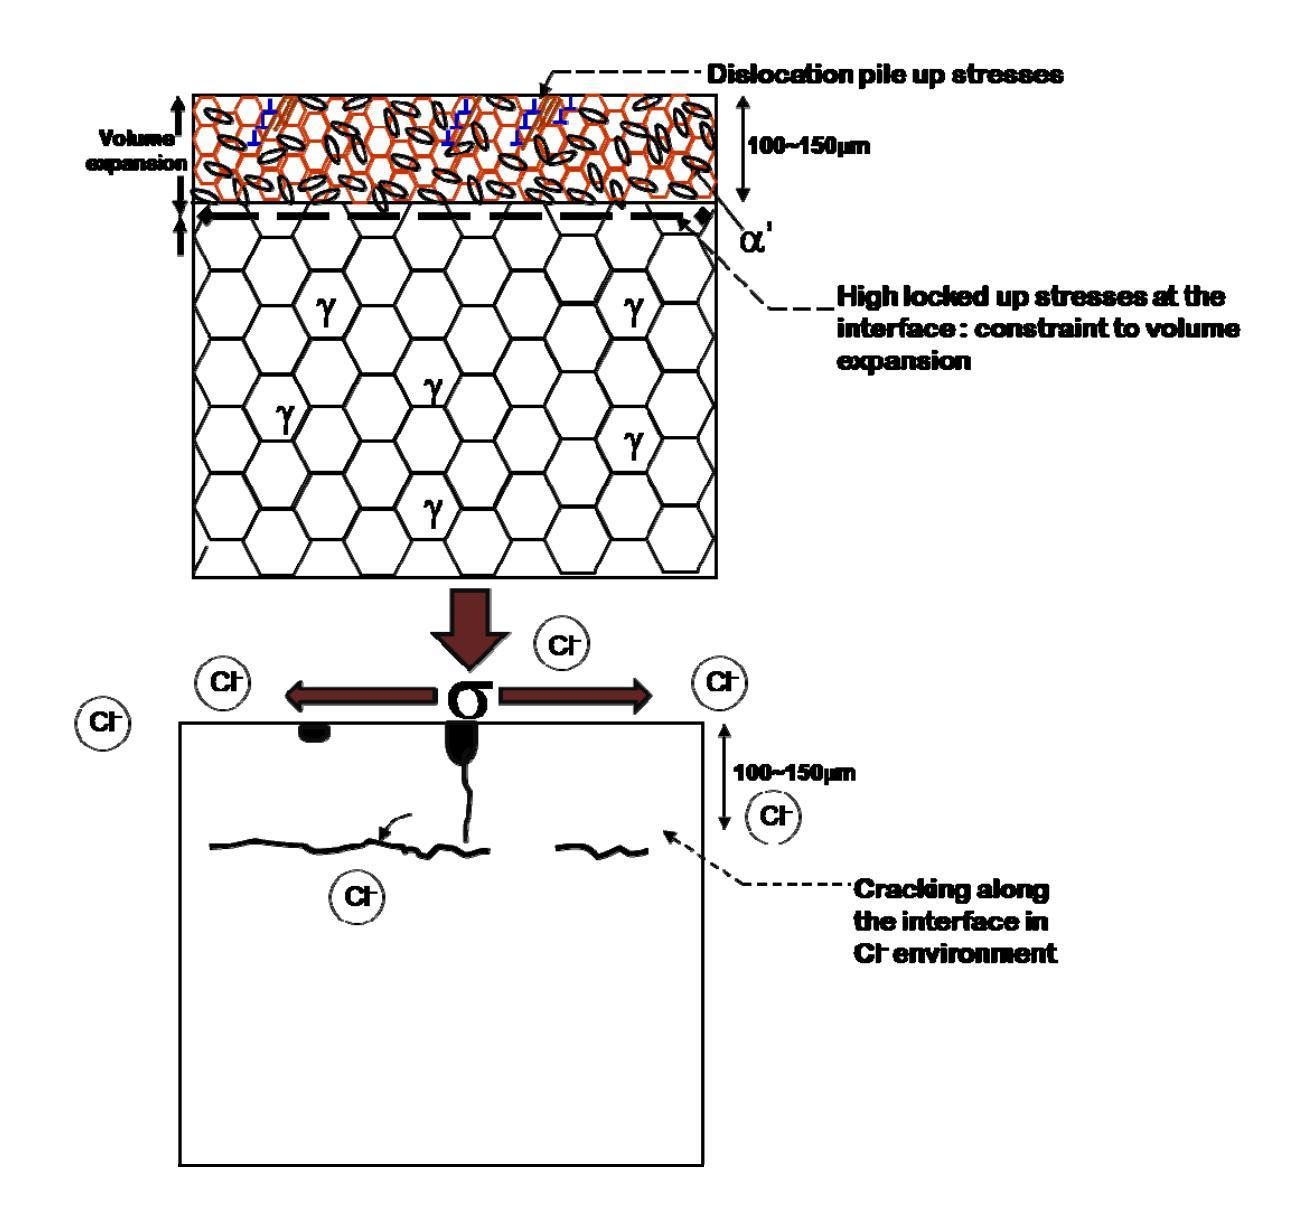
Fig. 6.5 (a) Schematic showing the work hardened layer formed in 304L stainless steel due to surface working and the (b) SCC behavior of the material in chloride environment.

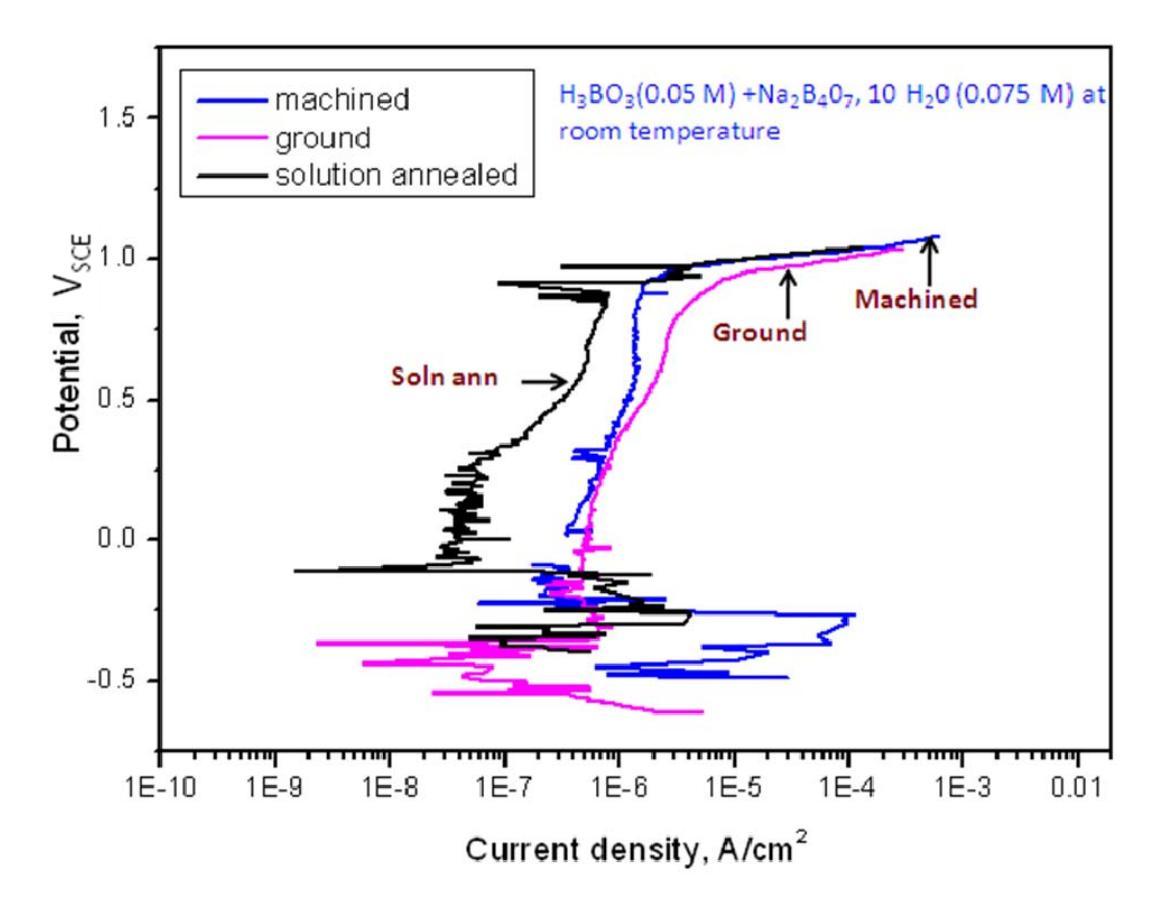
Fig 6.6 The electrochemical polarization behavior of machined, grounded and solution annealed 304L stainless steel in borate buffer solution at room temperature.

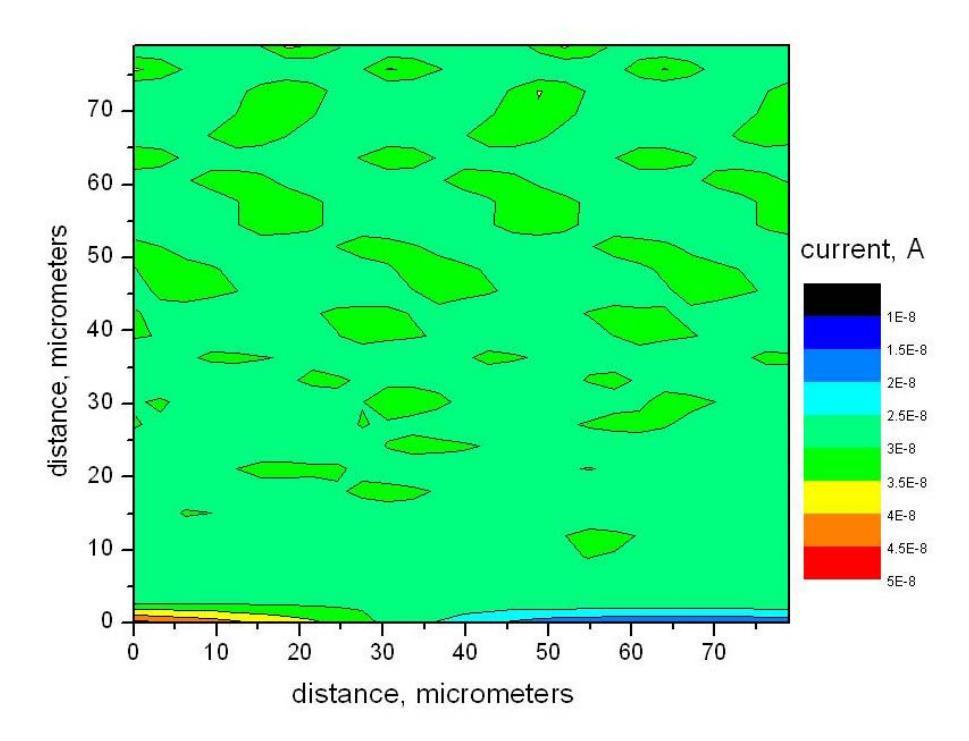
Fig. 6.7 Results of SECM for the solution annealed 304L SS showing 2D current contour plot showing the variation in current on the surface.

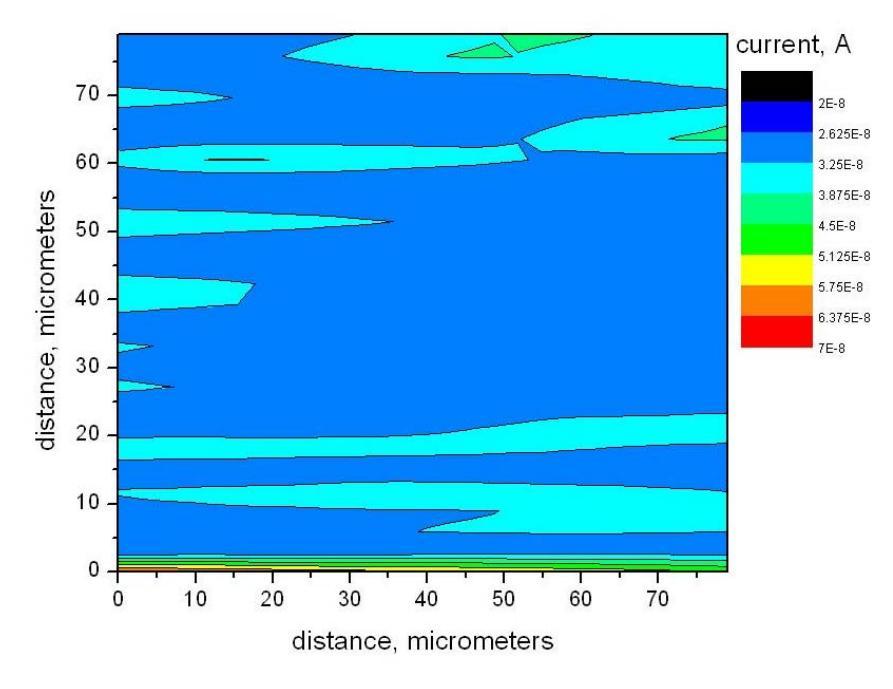
Fig. 6.8 Results of SECM for machined 304L SS showing 2D contour plot showing the variation in current on the surface.

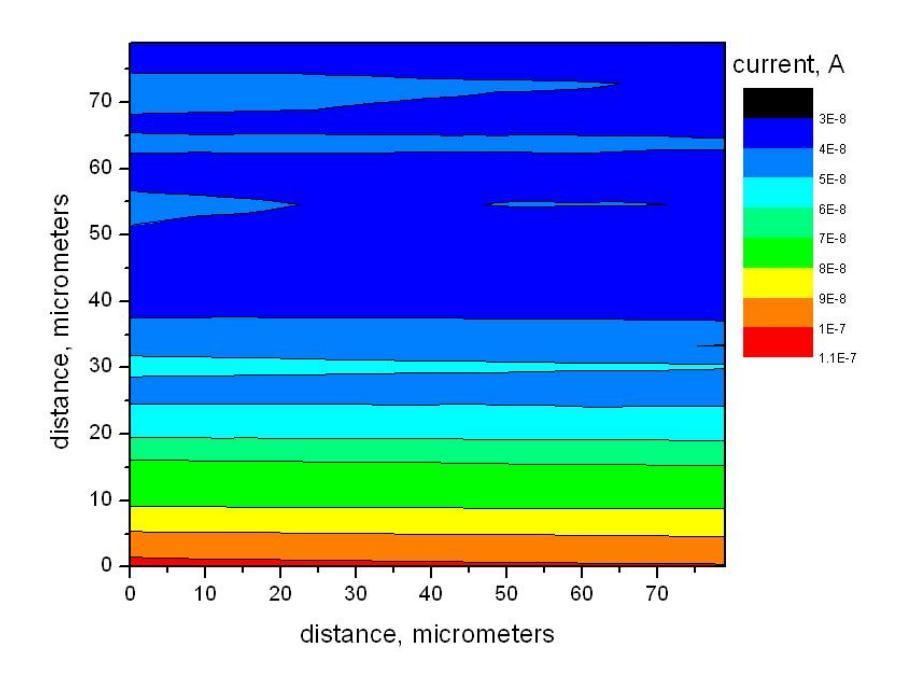
Fig. 6.9 Results of SECM ground 304L SS showing 2D contour plot showing the variation in current on the surface.
