Effect of Surface Working Operations on Electrochemical Corrosion and Susceptibility to Stress Corrosion Cracking of 304L Stainless Steel

A thesis submitted to the

Doctor of Philosophy

Homi Bhabha National Institute

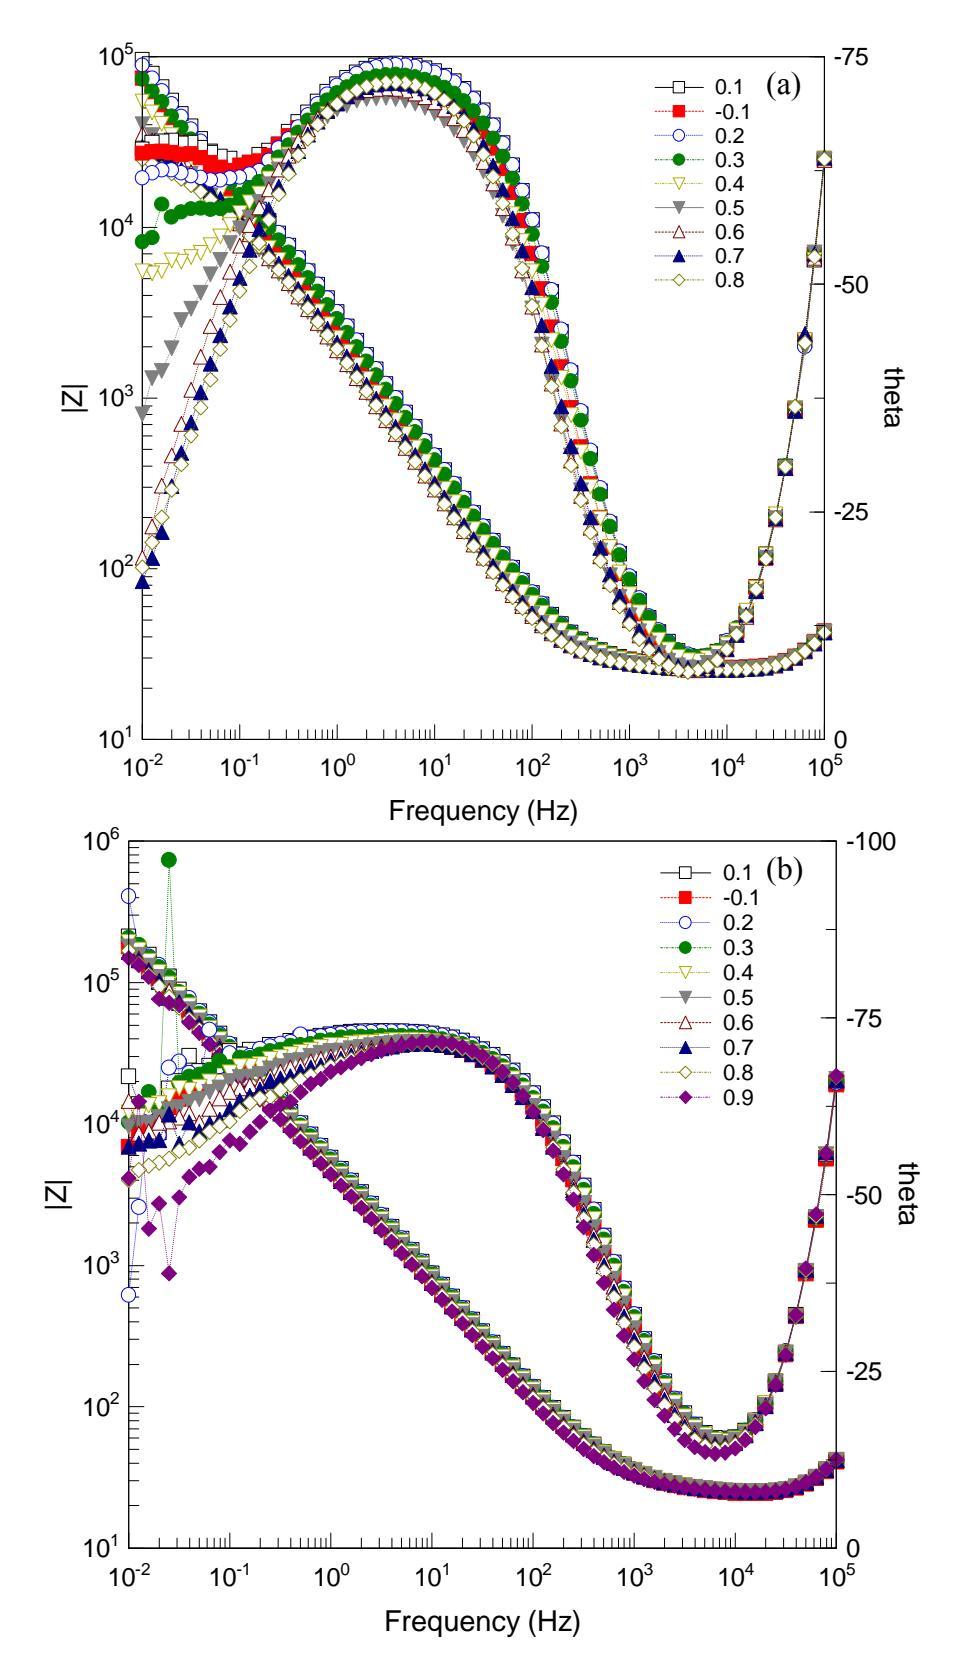
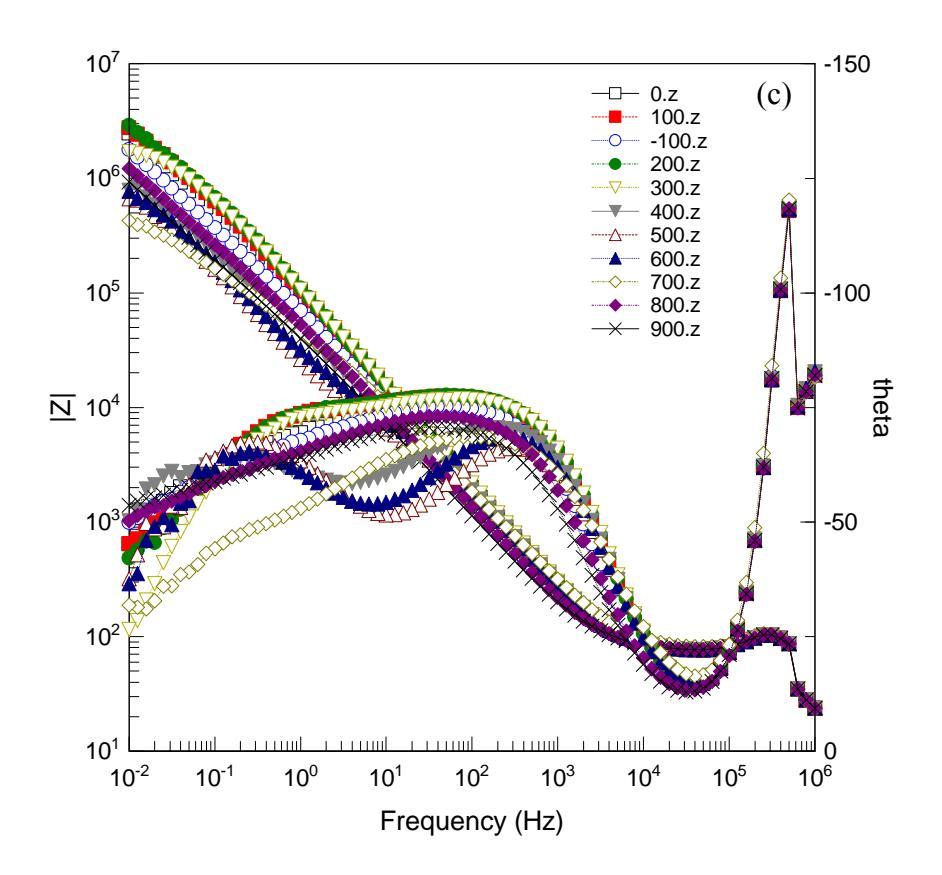
Fig. 6.10 EIS spectra of 304L stainless steel in borate buffer solution at room temperature in (a) solution annealed condition, (b) machined condition and (c) ground condition.

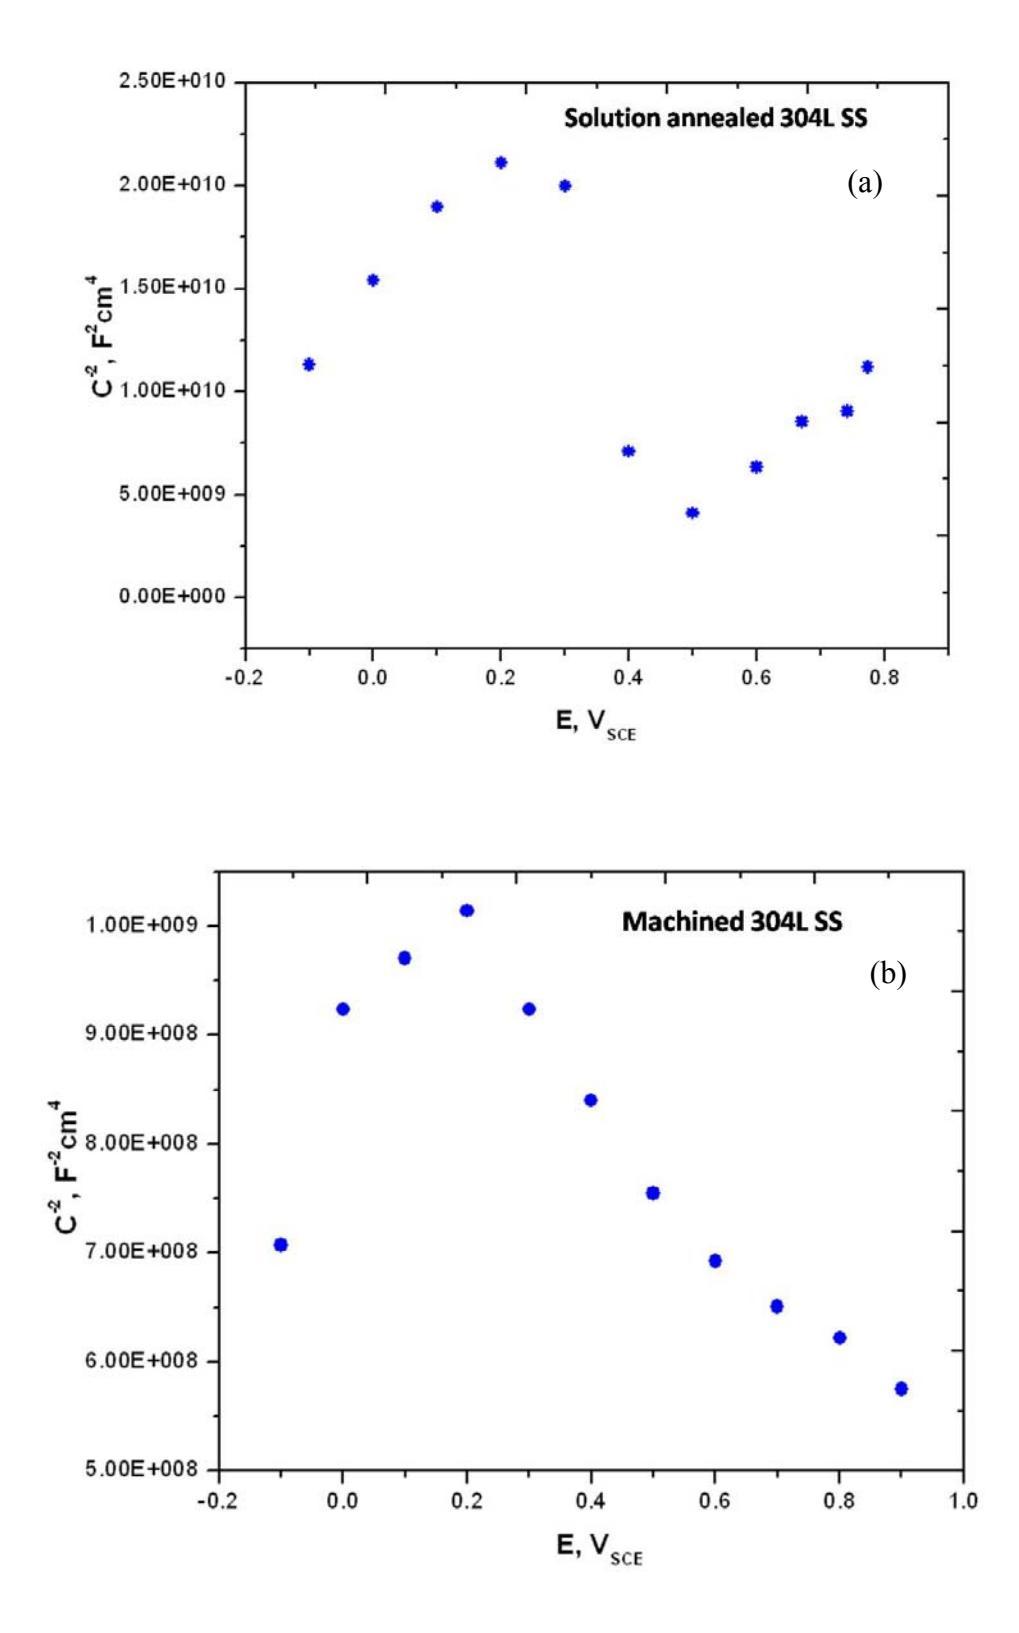
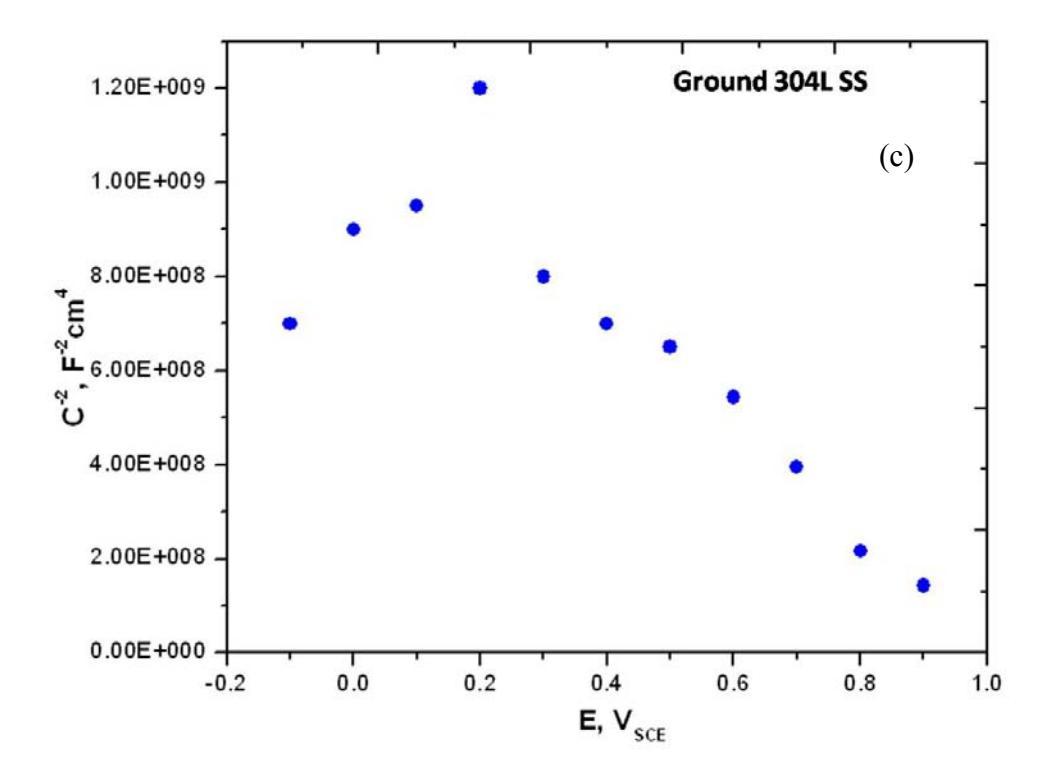
Fig. 6.11 Mott Schottky plots for 304L stainless steel in (a) solution annealed condition, (b) machined condition and (c) ground condition.

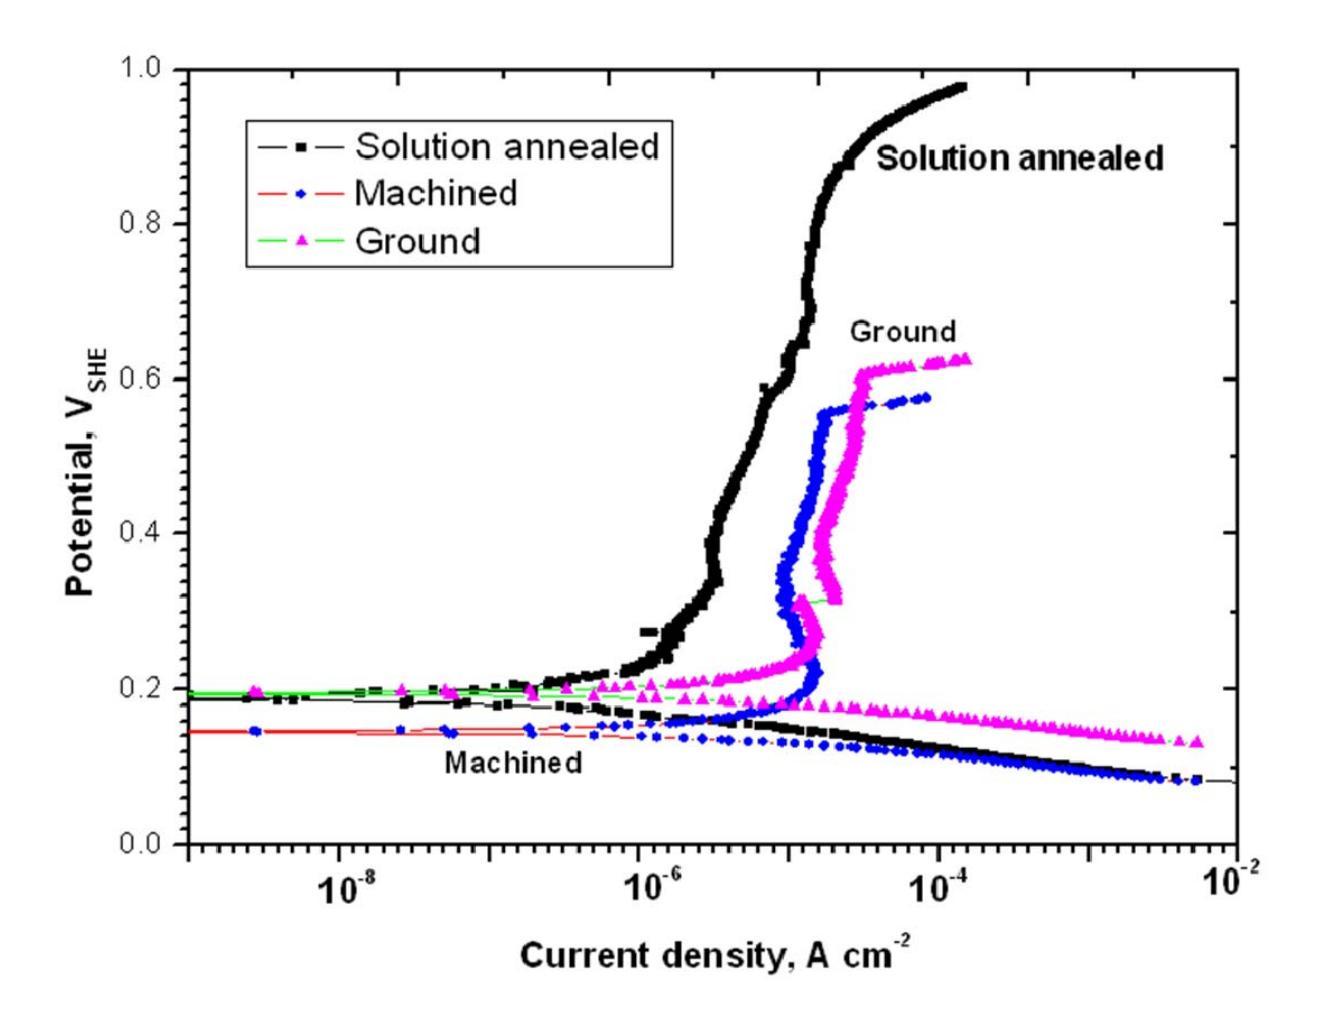
Fig. 7.1 Potentiodynamic polarization scan for solution annealed, machined and ground 304L austenitic stainless steel at 300°C, 10 MPa in borate buffer solution.

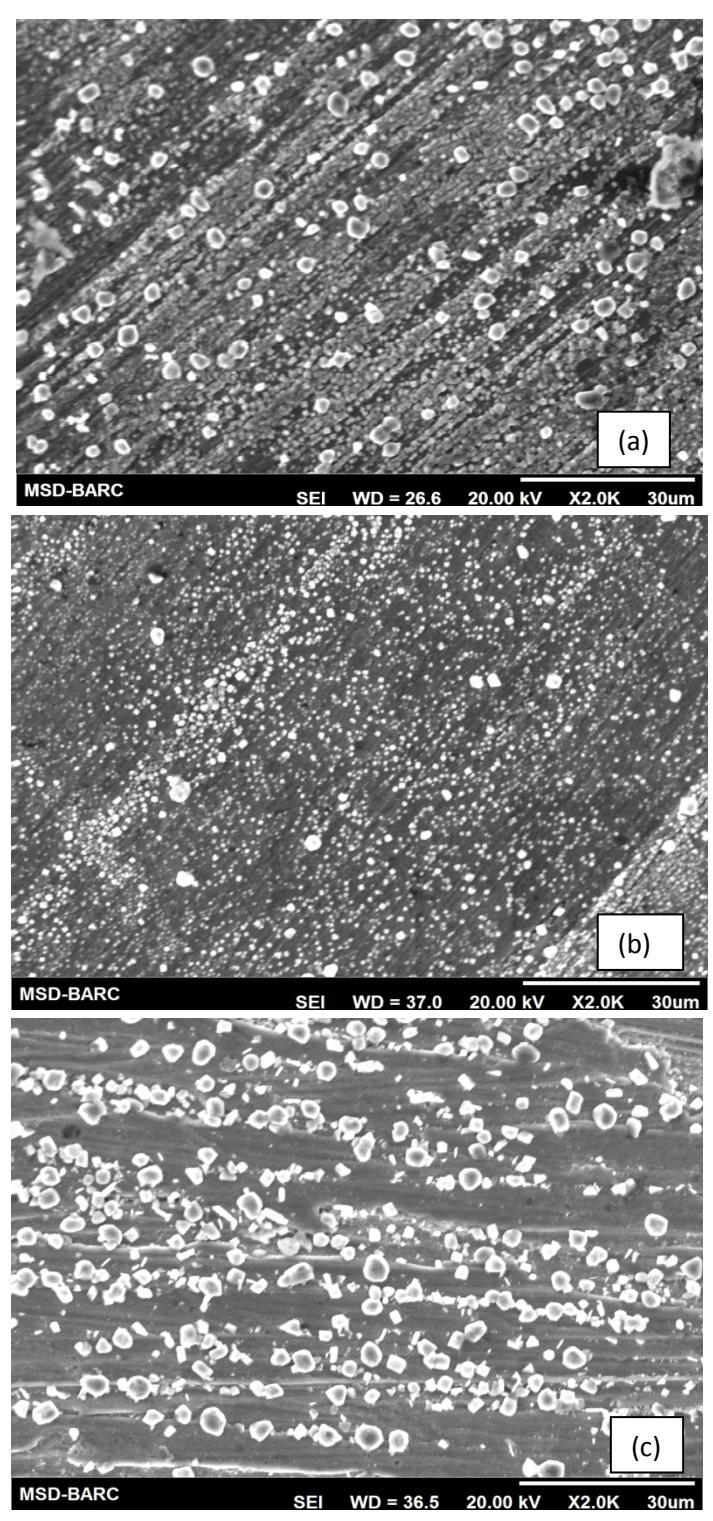
Fig. 7.2 SEM image of the oxide morphology on a) the solution annealed, b) the machined and c) the ground 304L austenitic stainless steel after exposure to 300°C, 10 MPa deaerated demineralised water for 360 h.

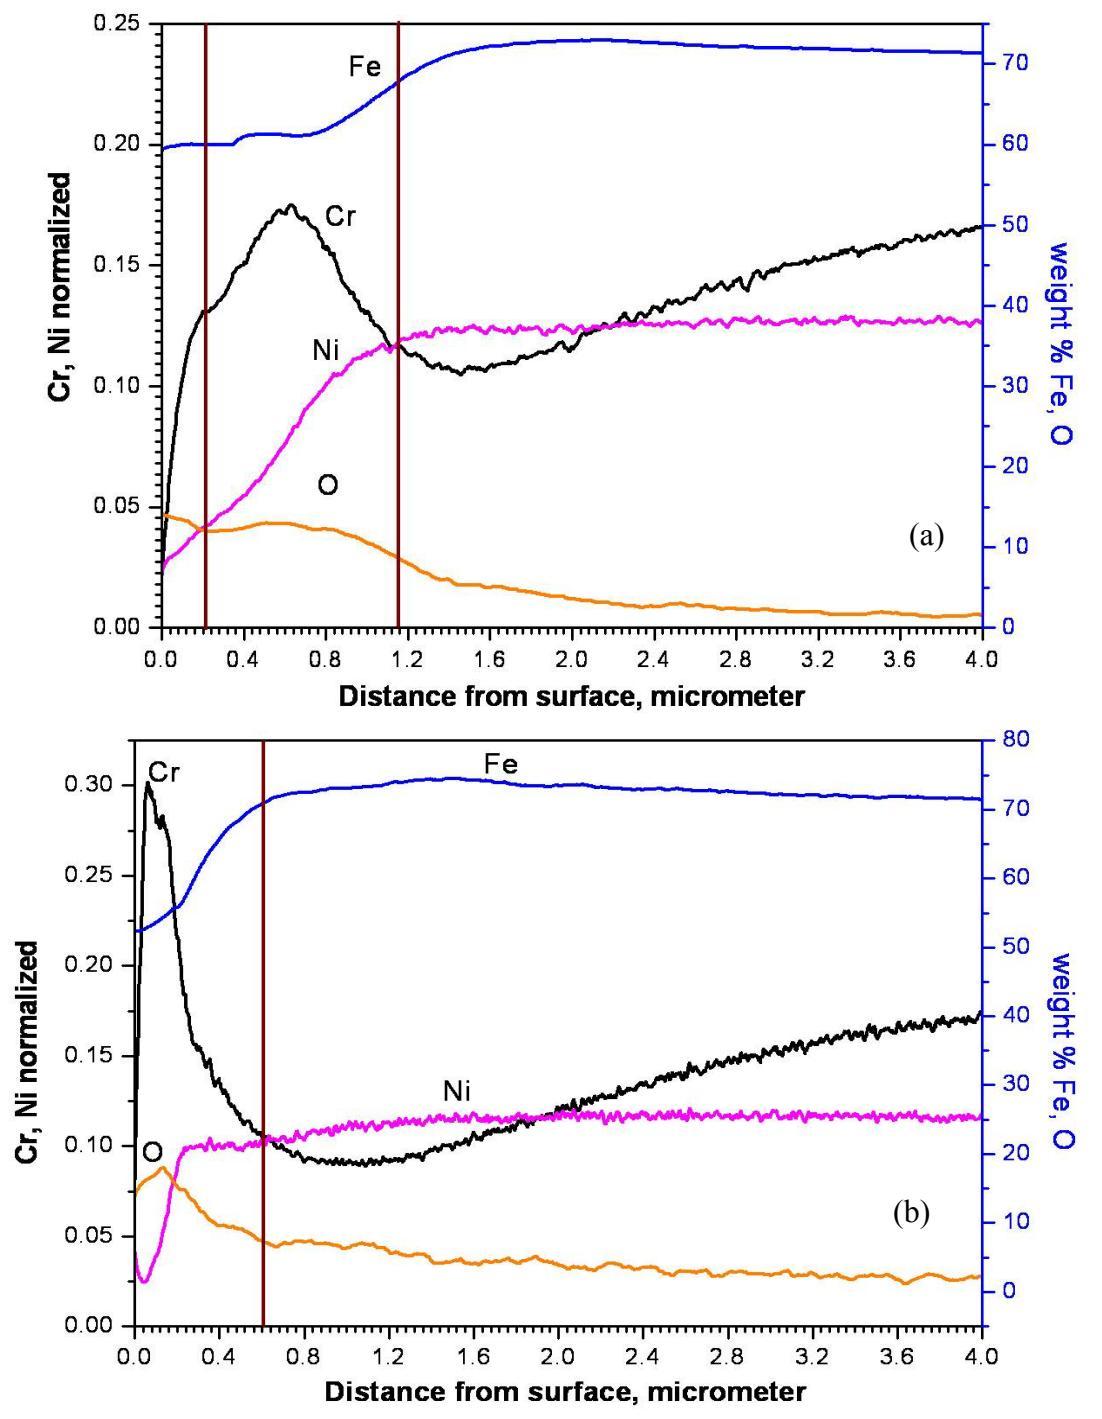
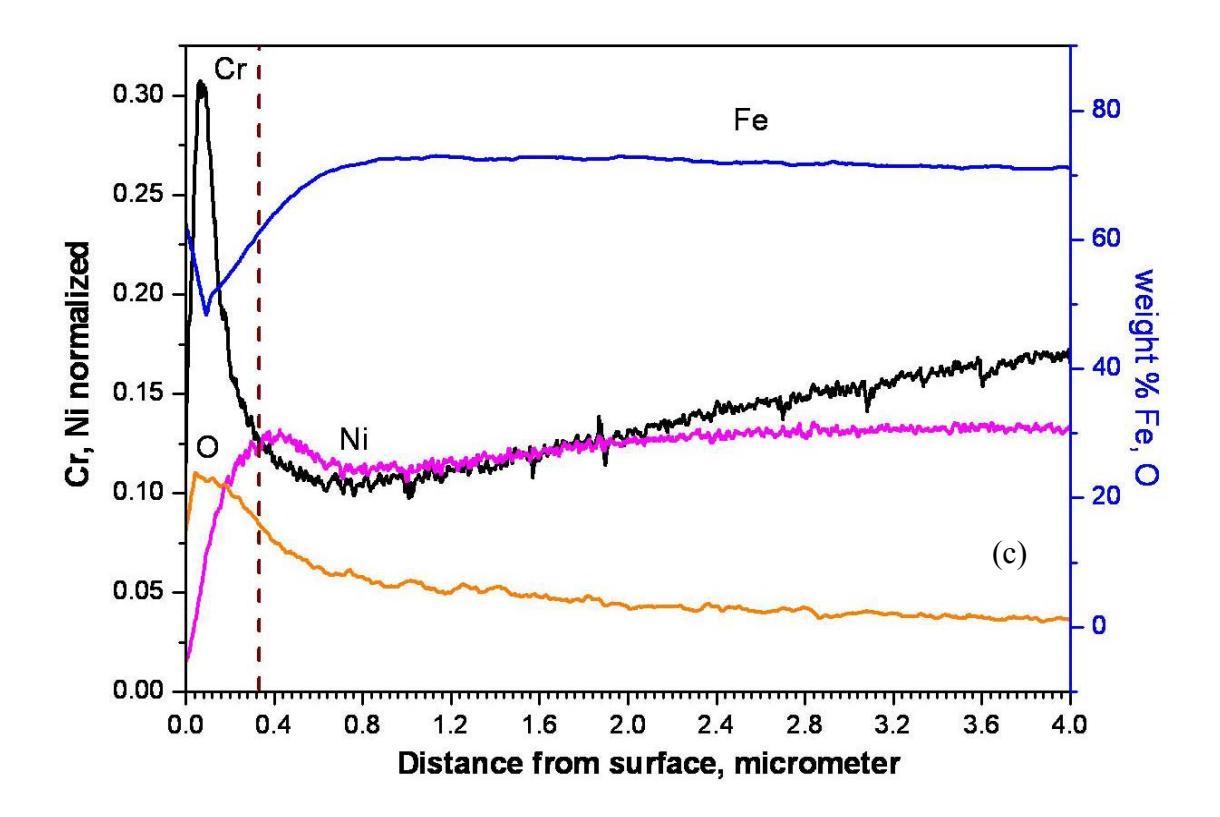
7.3 Elemental analysis along the depth of the oxide formed after exposure for 360 h to 300 °C deminerlaized deaerated water at 10 MPa on a) solution annealed, b) machined and c) ground 304L austenitic stainless steel by GDOES.

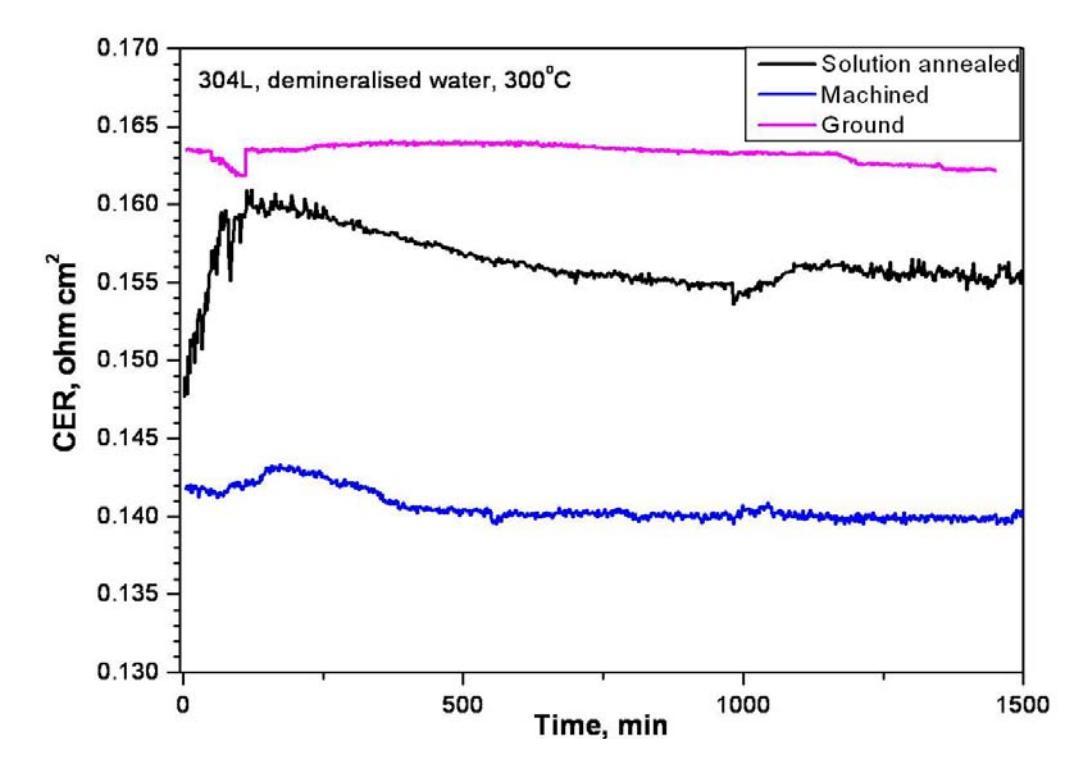
Fig. 7.4 Contact electric resistance of the oxide film formed on solution annealed, machined and ground 304L austenitic stainless steel at 300 C and 10 MPa in demineralised water environment.

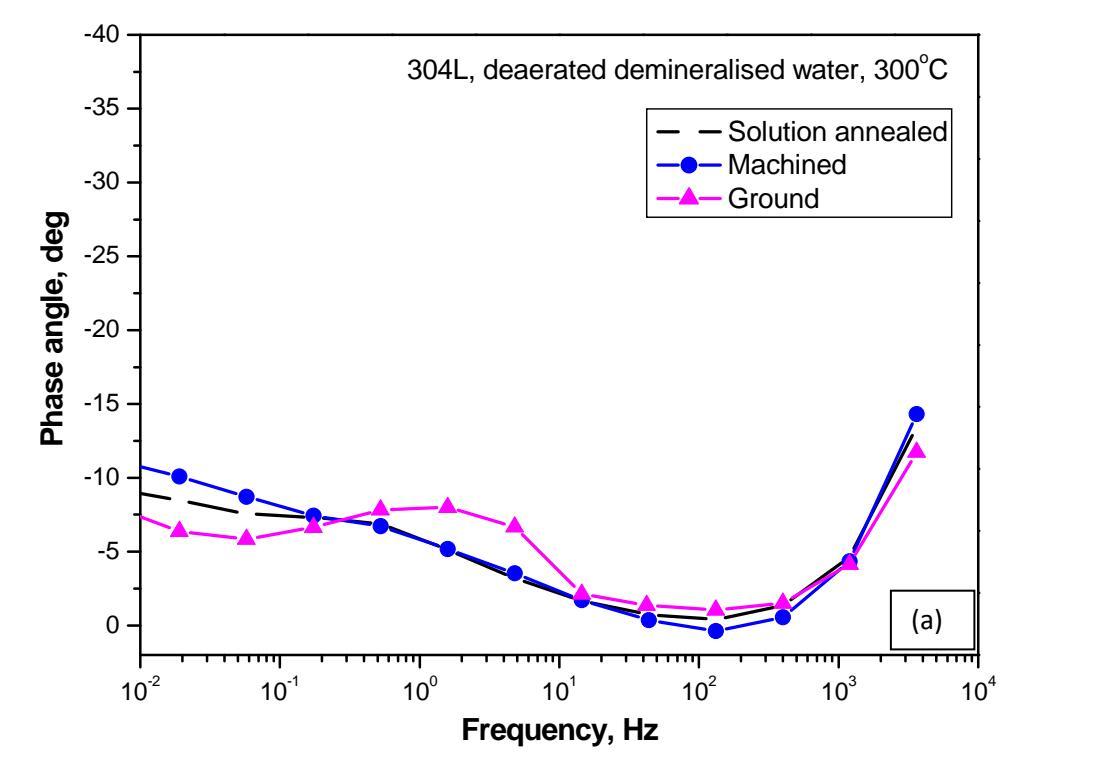
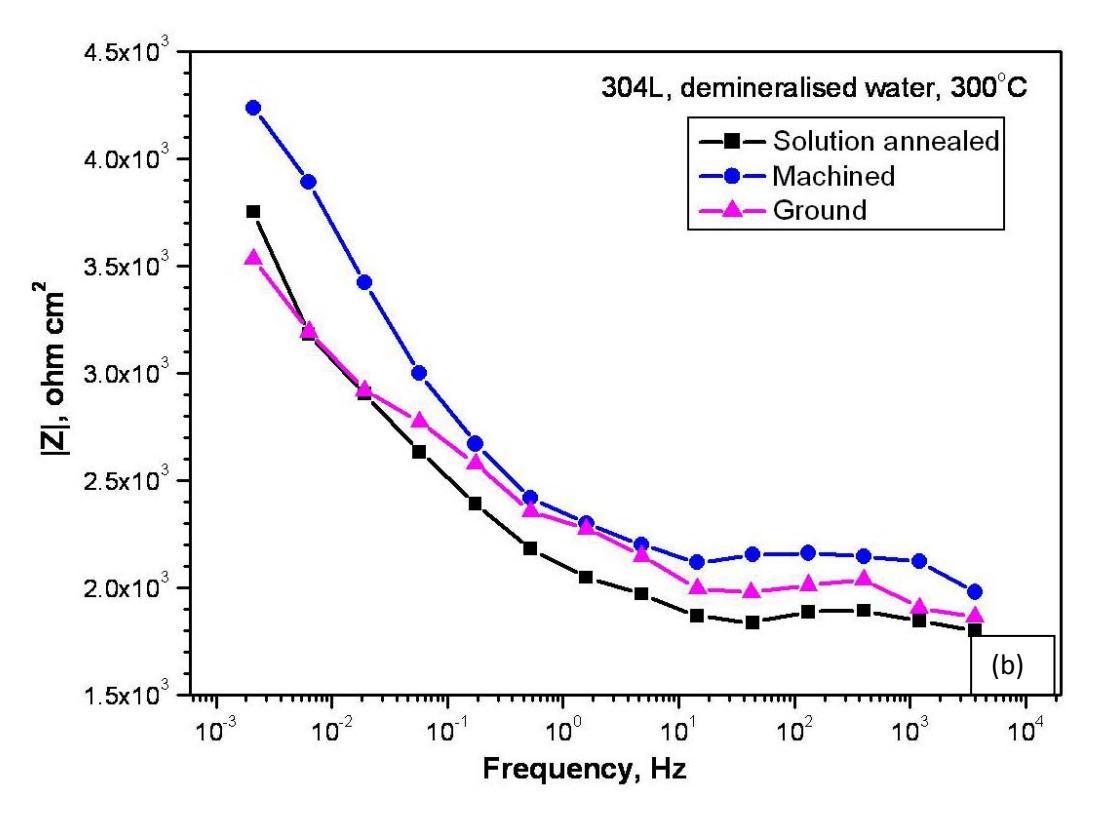
Fig. 7.5 Results of in-situ EIS studies in deaerated demineralised water environment at 300°C and 10 MPa by the help of CDE arrangement showing a) phase angle vs. frequency measurement and b) impedance vs. frequency measurement for solution annealed, machined and ground 304L austenitic stainless steel.
